TRANSPORTATION AGENCY FOR MONTEREY COUNTY

BRIDGE STRATEGY REPORT FOR THE MONTEREY PENINSULA LIGHT RAIL PROJECT

PARSONS
July 2005
May 2010 Update

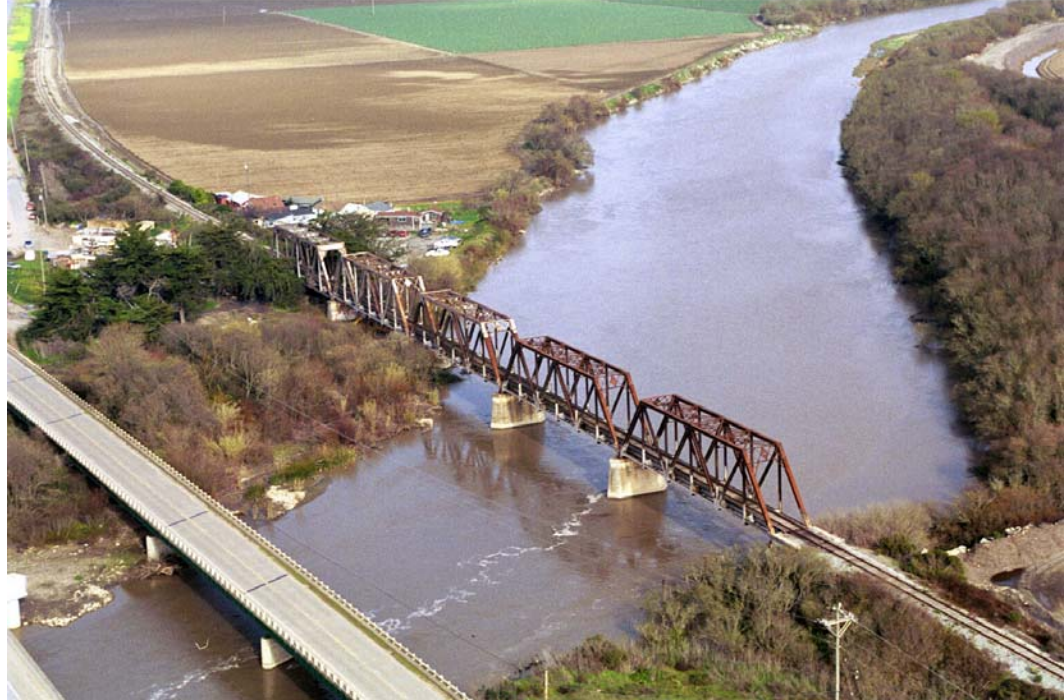
M.P. 113.46—Salinas River Bridge, 715-foot Steel Through Truss Bridge

The Salinas River Bridge is a 715-foot long, 5-span (143 feet each), truss bridge carrying a single track across the Salinas River. The structure consists of warren type, steel through trusses with concrete piers and abutments. The piers and the abutments are supported on 50-foot timber piles. The bridge was constructed in 1904 with a new first span added to the north end of the bridge in 1914. (See Appendix A drawings for the original bridge and the addition.) Abutments 1 and 2 and piers 2 and 3 are accessible by land and piers 4 and 5 are located in the river. We understand that the water level fluctuates considerably depending on the season. The bridge has extensive corrosion causing loss of structural section through the bridge members. Generally the primary load carrying members have a moderate loss; however, some of the secondary members have extensive corrosion and need replacement.

During the 2010 re-inspection and re-evaluation, the bridge was found to have extensively advanced corrosion causing from 5 to 40 percent additional loss of structural section throughout the bridge members. While increased, the primary load carrying members still have a moderate loss except in Span 1 where up to a 40 percent increase was found. With the re-inspection, a majority of the secondary members in Spans 2 through 5 now have extensive corrosion and need replacement. The re-inspection also revealed that the open timber deck must also be replaced.

In addition to the replacements listed above, the 2010 re-inspection and re-evaluation found that there was a significant increase in the amount of bracing requiring replacement, including virtually all of the top lateral and sway bracing in Spans 2 through 5. A much higher percentage of lacing bars or lattice bracing and lateral bracing connection members (gusset plates) throughout the bridge now require replacing. Nearly all the chord member cover plates now require replacement and, to extend the life-span of the repairs to a minimum of 30 years, the significant increase in top flange deterioration in the Span 1 bottom chords and diagonals requires that the channel top flanges be cut off and replaced with new flange angles bolted to the webs of the existing members before other new replacement material can be attached.

The 2010 re-inspection and re-evaluation also found that deterioration of the open deck timber ties had also increased since the 2001 M&M inspection and that the ties were now in fair to poor condition such that the entire deck required replacement. With all of the additional steel repairs, the timber deck replacement, and cleaning and painting, the cost of the existing bridge rehabilitation in 2010 dollars is now \$6.3 million as detailed in Appendix F.

Parsons recommends replacement of the bridge on a new downstream alignment within the existing railroad right of way. Although there is a higher initial cost for a new bridge the overall life cycle cost spread over the 75 plus year life would be lower. A new bridge will also provide less risk as it will be designed to current codes in regards to seismic and high water events. This also provides for assurance that substantial interruption (1 to 2 years) caused by a seismic or high water event to passenger services would be minimized or eliminated. The cost of a new bridge ranges between approximately \$8 and \$10 million for concrete and steel superstructure alternatives respectively. At this time it appears the concrete superstructure would provide the preferred alternative but this would be confirmed during the next phase of engineering development.

If the funds are not available to replace the bridge, Parsons recommends rehabilitating the bridge, including installing the monitoring and signaling system for both seismic and scour, to carry very limited service as **now** described in service options 3 and 4. The possibility of an extended interruption in service to a large number of patrons in the case of significant damage caused by an earthquake or high water event **must, however, be considered**. Note **also** that a **concrete** bridge replacement would have a lower life cycle cost since the existing bridge will need replacement in 15 to 20 years **or need to have annual tree trimming and bridge washing maintenance and have the timber deck replaced and cleaning, minor steel repairs, and painting performed on a 15 year cycle.**

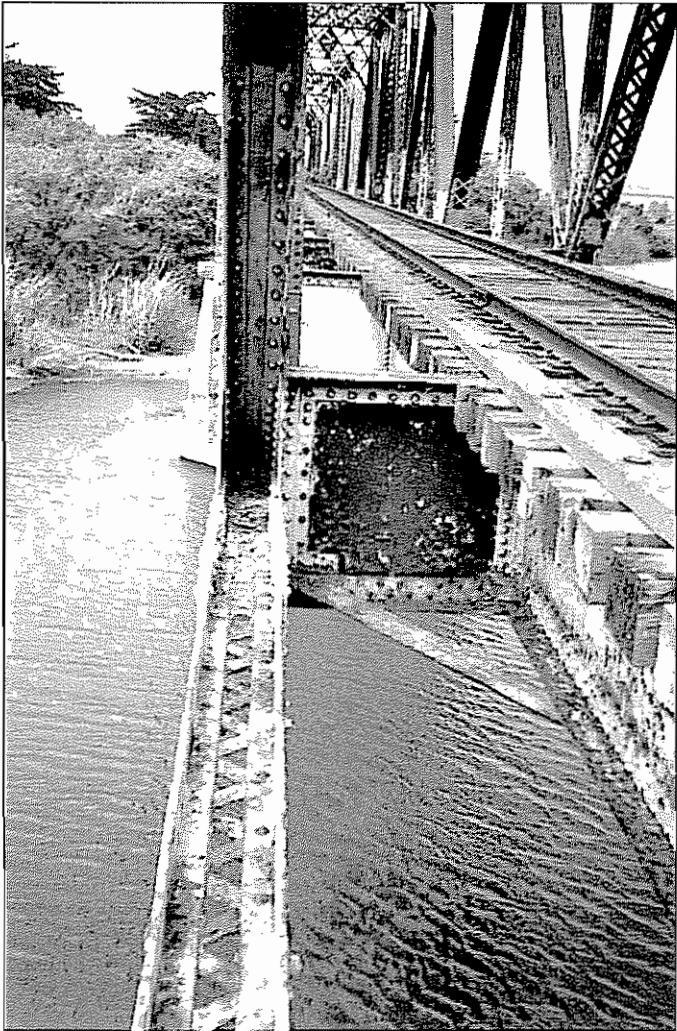
Photograph No. 3 (left) – View shows truss members and floor system components in Panel 5 of Span 4, right side. Note various paint conditions of the bottom chord, diagonal, floorbeam, and stringer.

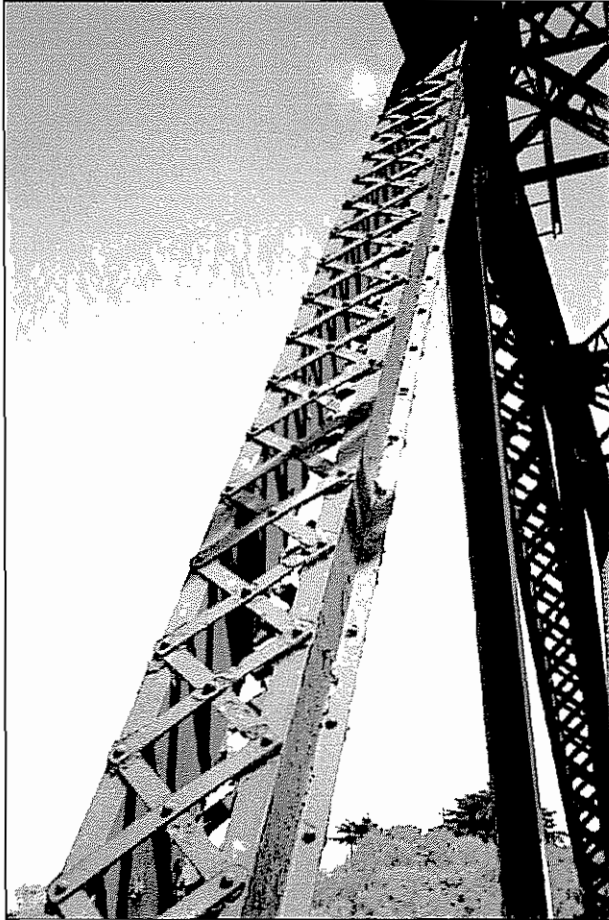
Photograph No. 4 (left) – View shows Diagonal U3-L4 of the right truss of Span 5. Note that there is very little paint remaining on the diagonal.

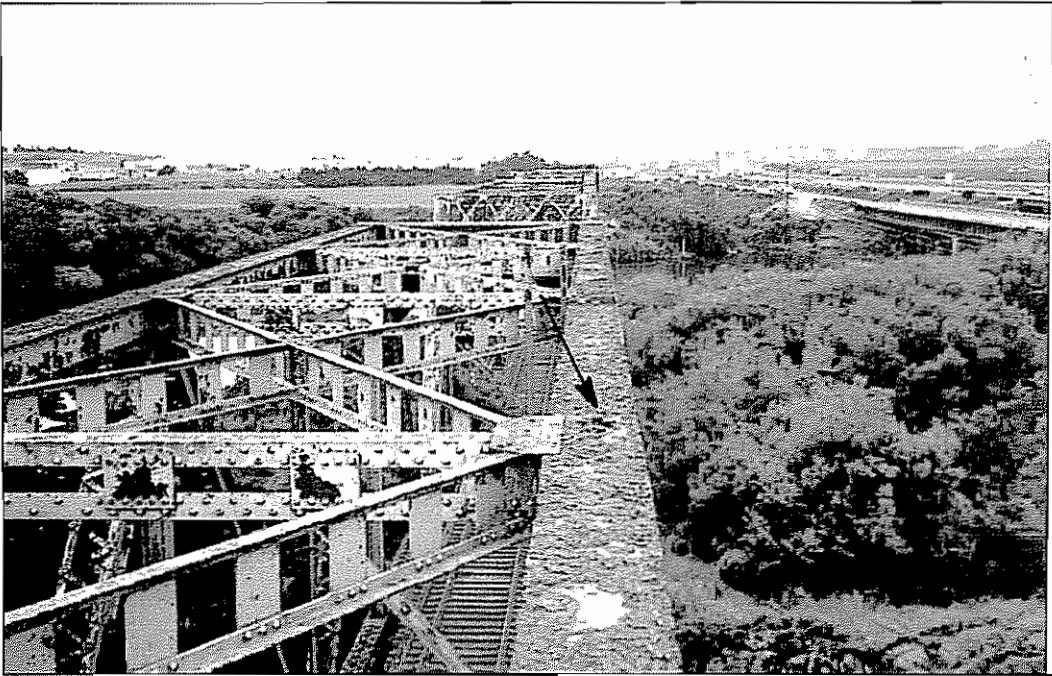
Photograph No. 7 – View of the top chord of Span 1 from Panel Point U1R. Note extensive corrosion and section loss of the cover plate, including holes at U2R (arrow).

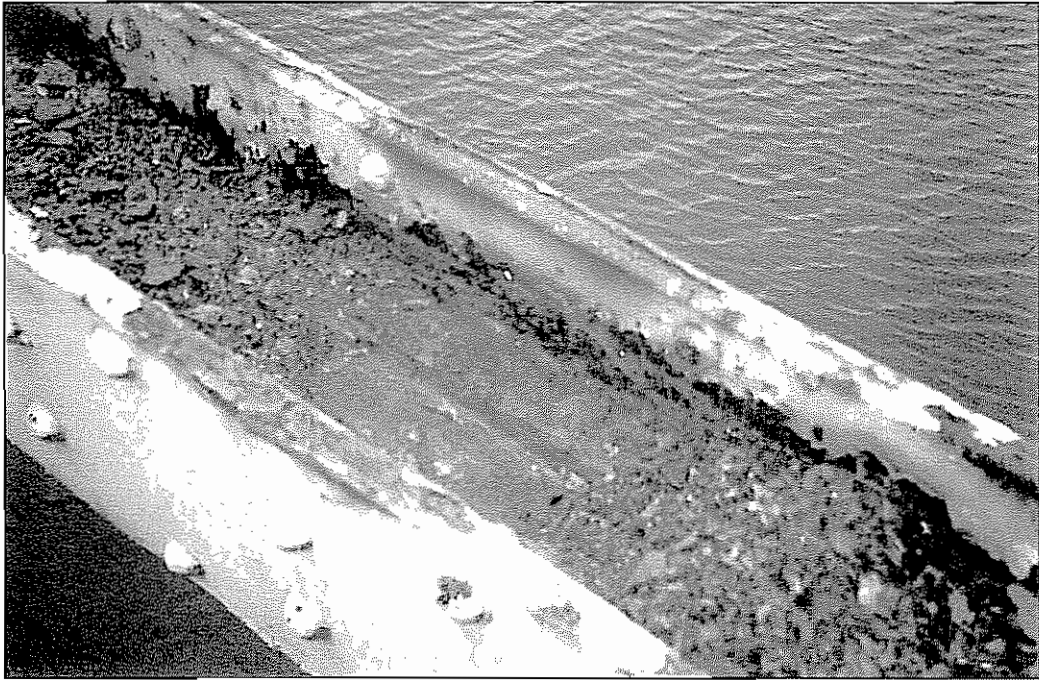
Photograph No. 8 – View shows corrosion and minor section loss at the web plate and Outboard flange of the bottom chord in Panel 4 of Span 4, right side. Also note minor section loss and spreading at the flanges due to crevice corrosion.

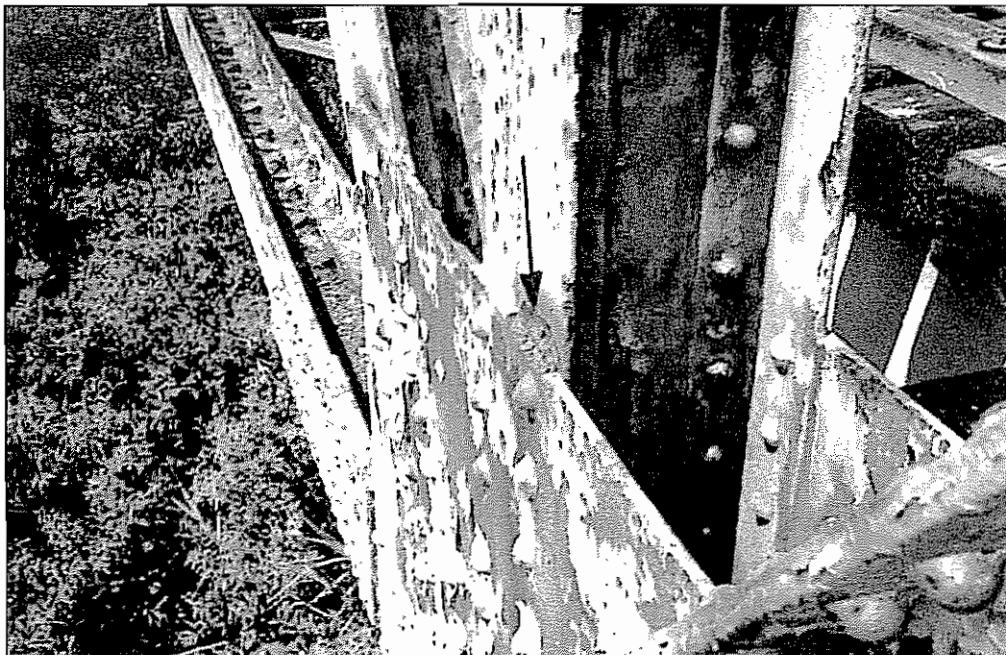
Photograph No. 9 – View shows an isolated area of section loss in the outboard flange of the post at Panel Point L4L of Span 2 (arrow).

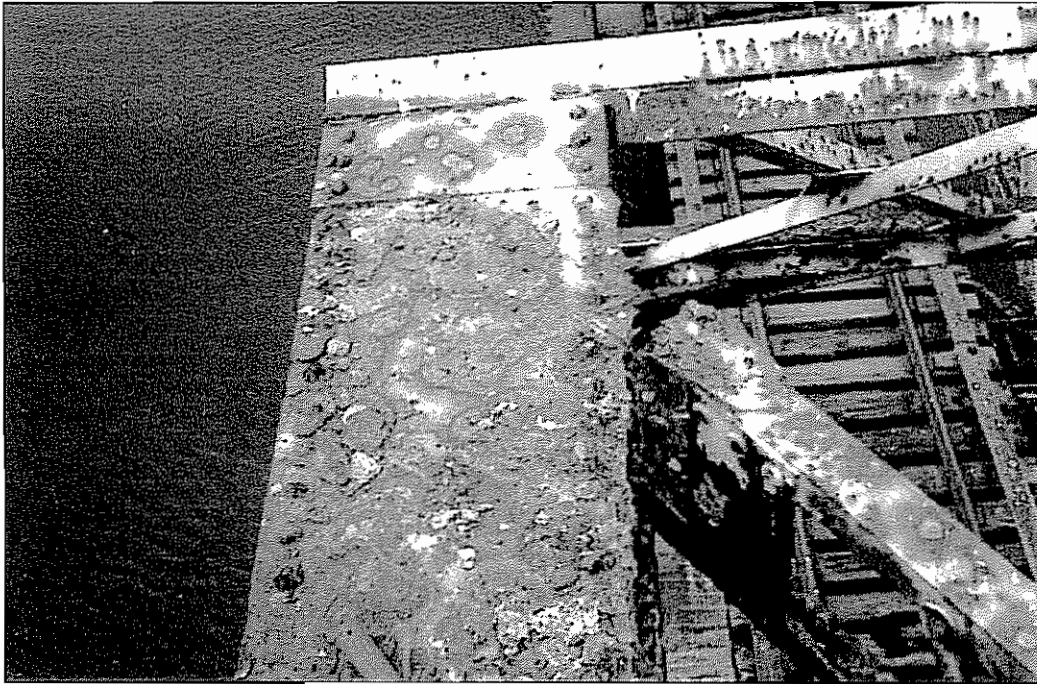
Photograph No. 10 – View shows 100% section loss of the upper connection plate of the top lateral, at Panel Point U5L of Span 3.

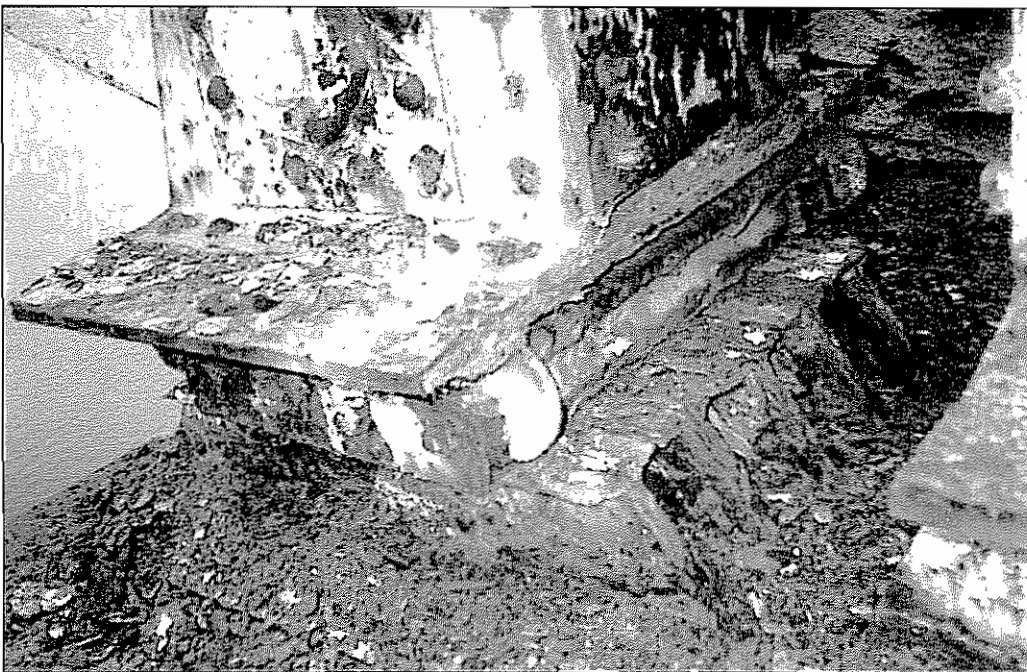
Photograph No. 13 – View of the truss expansion bearing of Span 3, right side. Note extensive corrosion at back-to-back channels of the bearing pedestal.

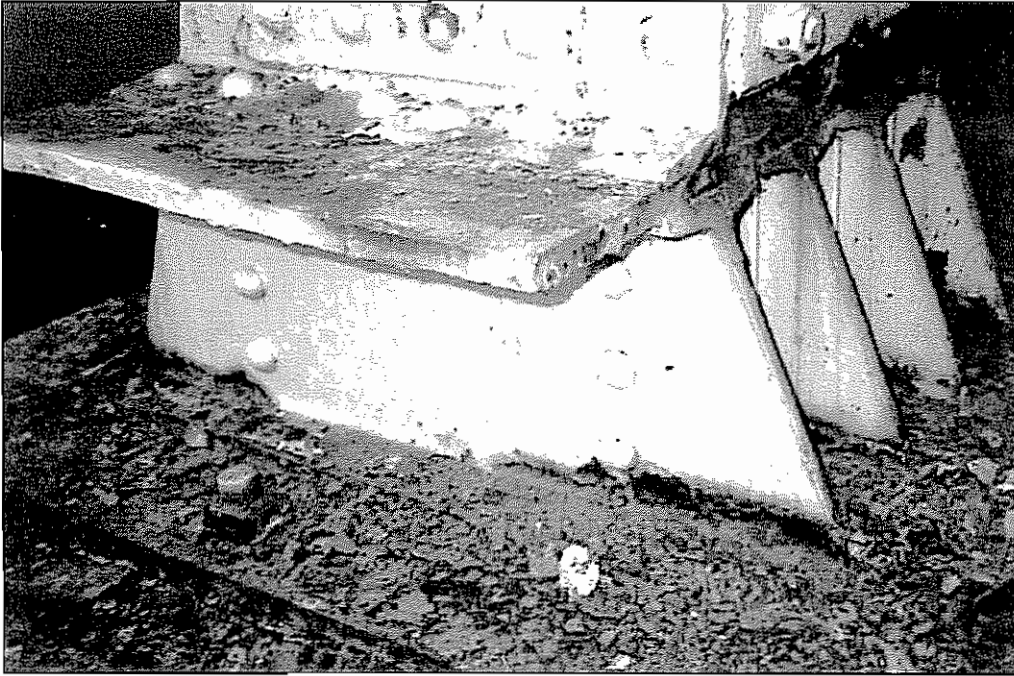
Photograph No. 14 – View of the truss fixed bearing of Span 3, left side. Note corrosion and section loss along the bottom of the webs of the bearing pedestal I-beams.

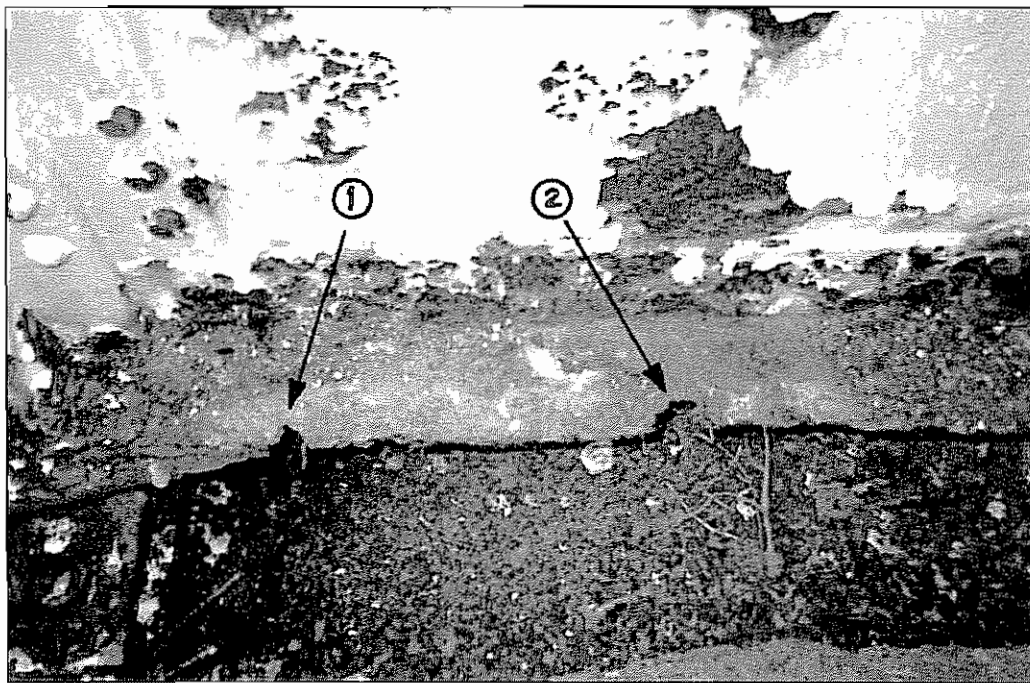
Photograph No. 15 – View shows the bottom flange of Floorbeam 6 of Span 1, right side, where 70% section loss was noted 15” from the end of floorbeam (arrow 1) and 40% section loss was noted 31” from the end of floorbeam (arrow 2).

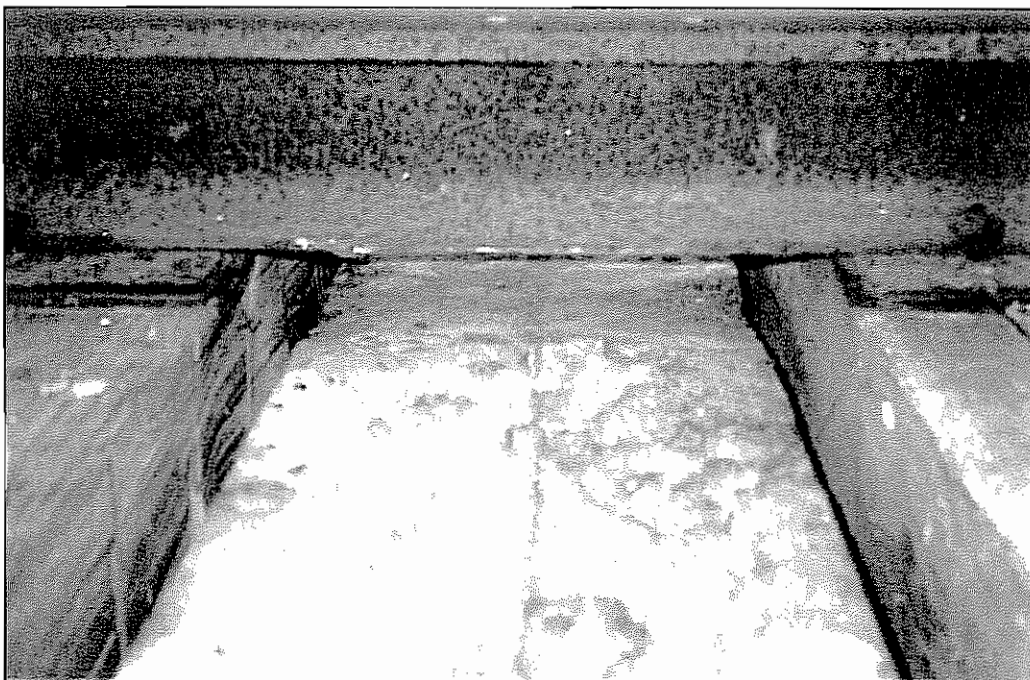
Photograph No. 16 – View shows section loss in the top flange of Floorbeam 5 of Span 4, under the left rail of the track.

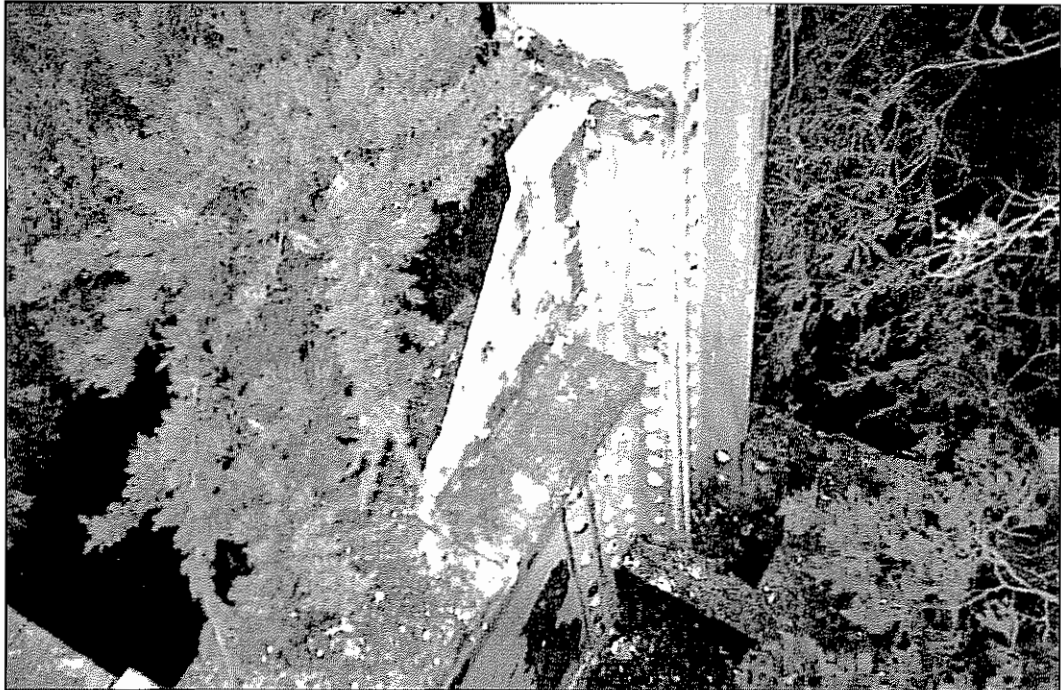
Photograph No. 20 – View shows the left floorbeam bracket of Floorbeam 3 of Span 1, where 50% section loss was noted at horizontal legs of the angles connecting it to the floorbeam.

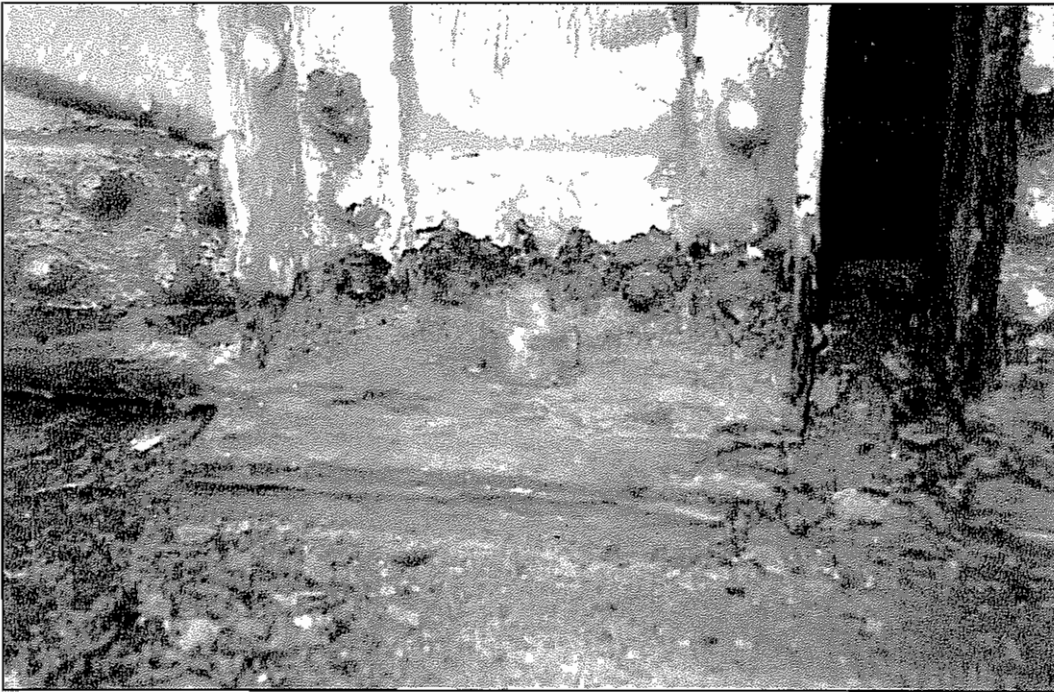
Photograph No. 21 – View of the right stringer expansion bearing of Span 4, at Pier 4. Note corrosion at the stringer bottom flange, sole plate and bed plate, and minor section loss at the bottom of the bearing stiffeners.

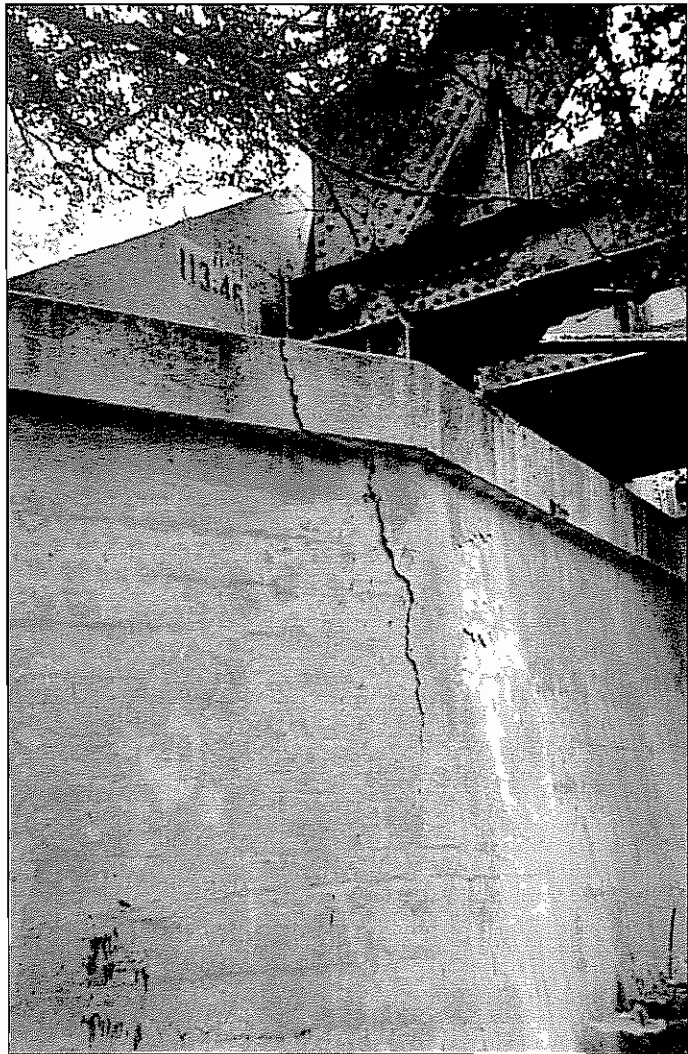
Photograph No. 22– View shows a crack in Abutment No. 1, at the right truss bearing.

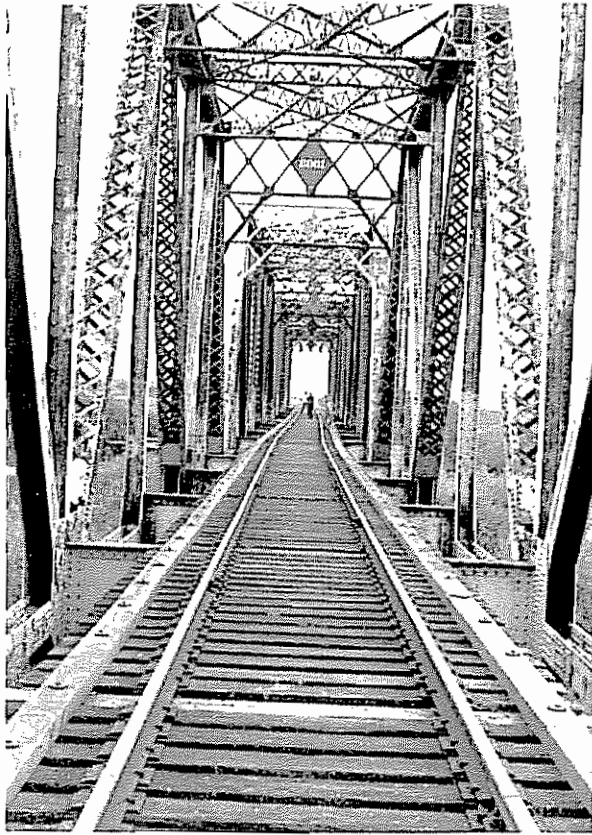
PHOTOGRAPH NO. 16 - View of 6-9 inch
left shift in the track at Pier 3.

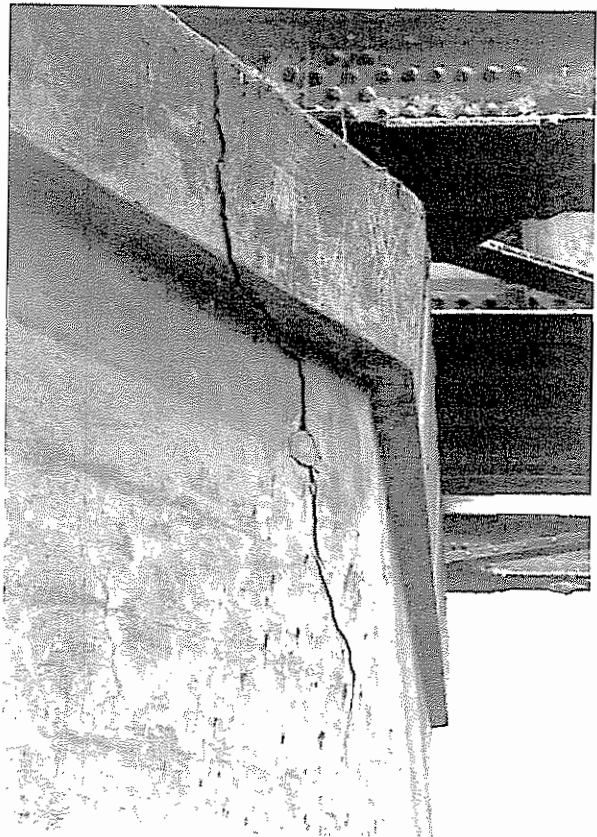
PHOTOGRAPH NO. 17 - View of the
west abutment crack cause by
the truss anchor bolt (Span 1)
holding the fixed bearing in
place.

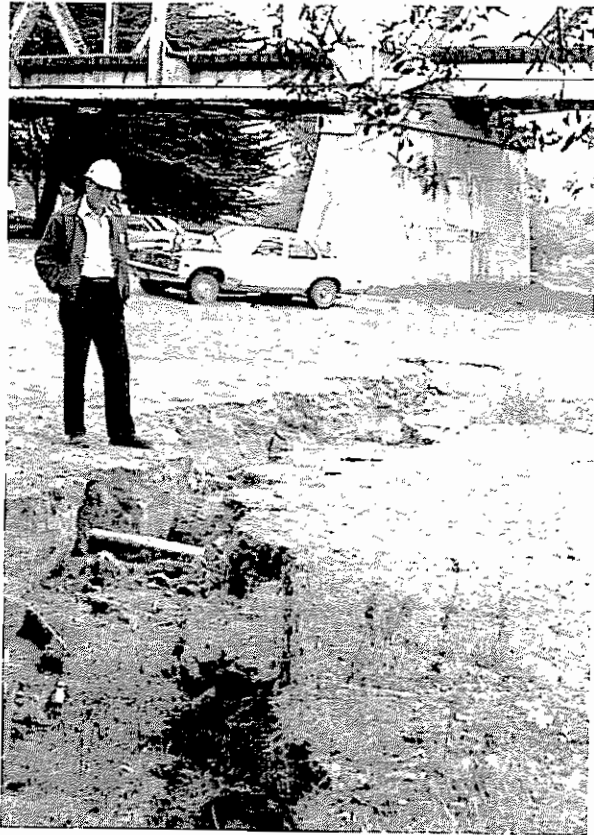
PHOTOGRAPH NO. 20 - View of a ground
fissure between Piers 2 and 3.
Pier 2 is in the background.

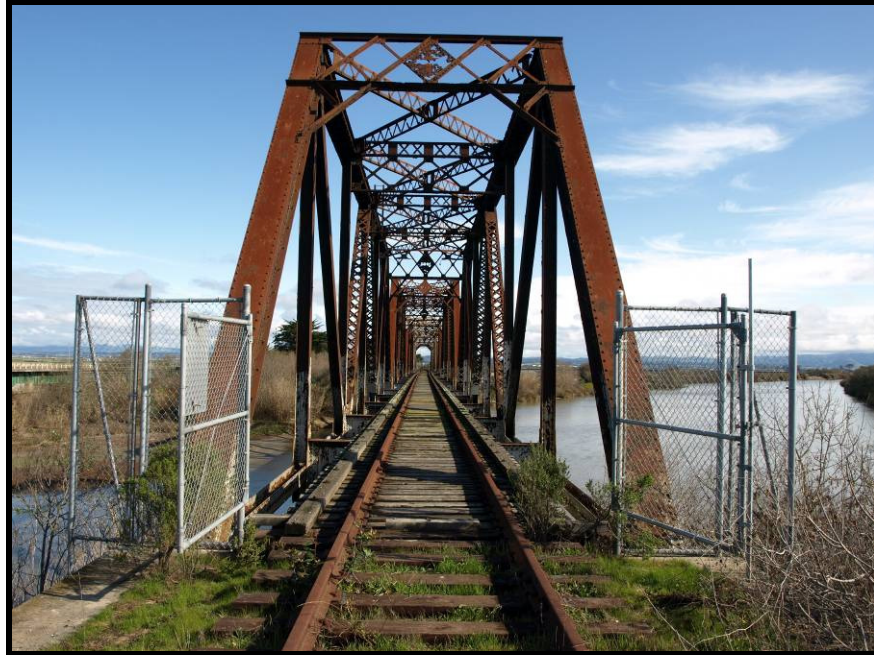
Photograph No. 1 – View of paint loss on various members beginning at Span 5 and looking North.

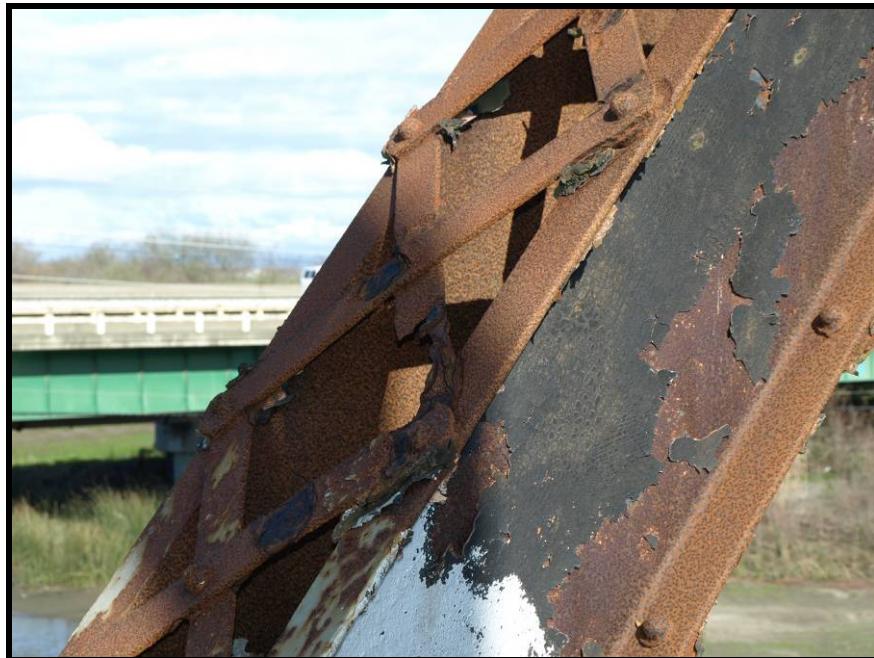
Photograph No. 4 – View of paint deterioration of Diagonal U3-L4 of the right truss of Span 4.

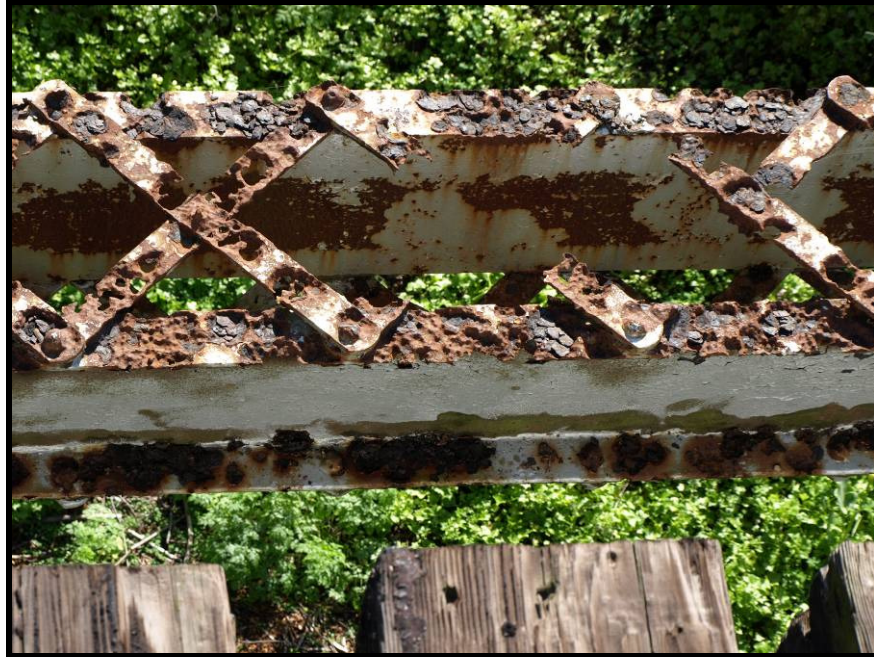
Photograph No. 5 – View shows corrosion and section loss of flanges of bottom chord in Panel 4 of Span 1, right side.

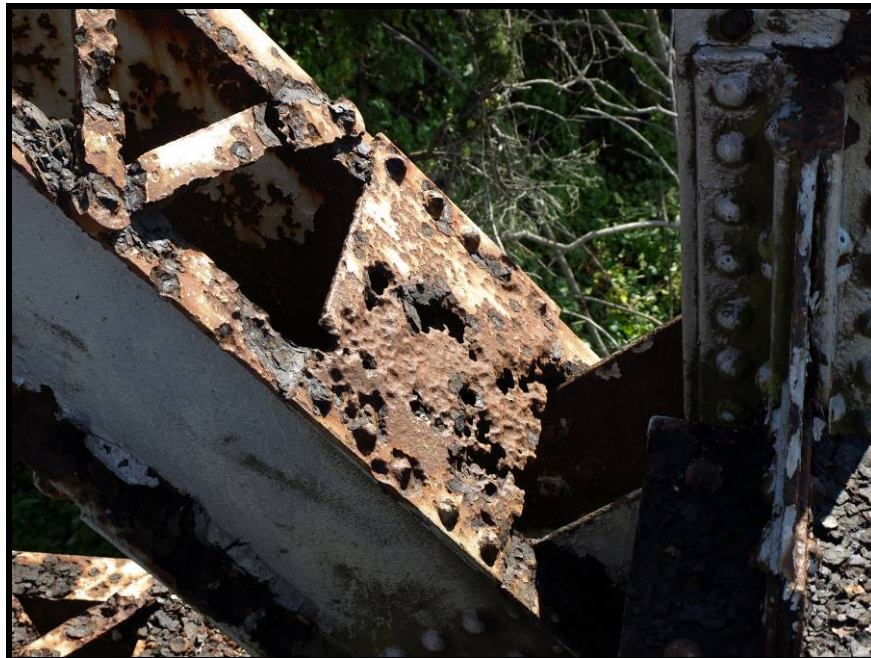
Photograph No. 6 – View shows corrosion and section loss on flanges of diagonal U1-L2 in Panel 2 of Span 1, right side.

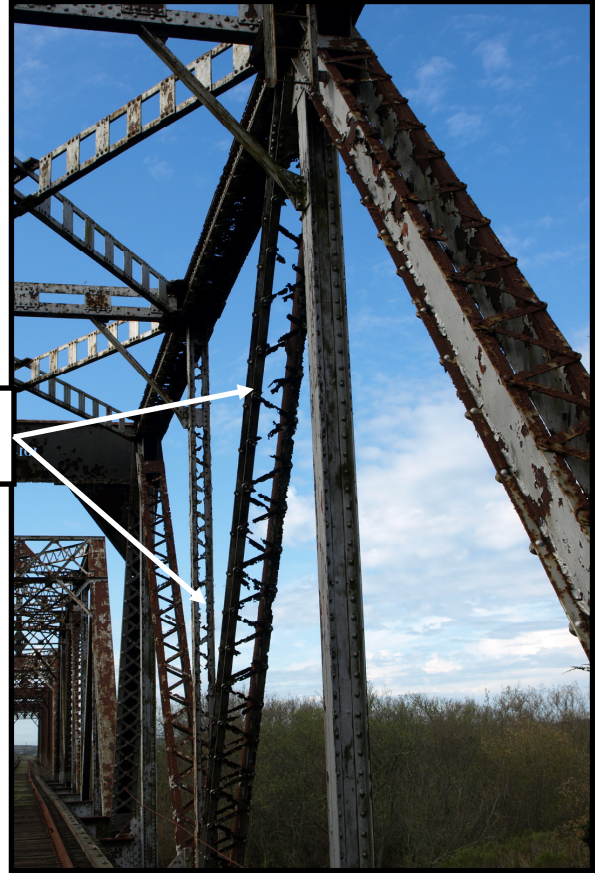
100% Lacing Section
Loss Top & Bottom

100% Lacing Section Loss Top
& 50%-100% Loss Bottom

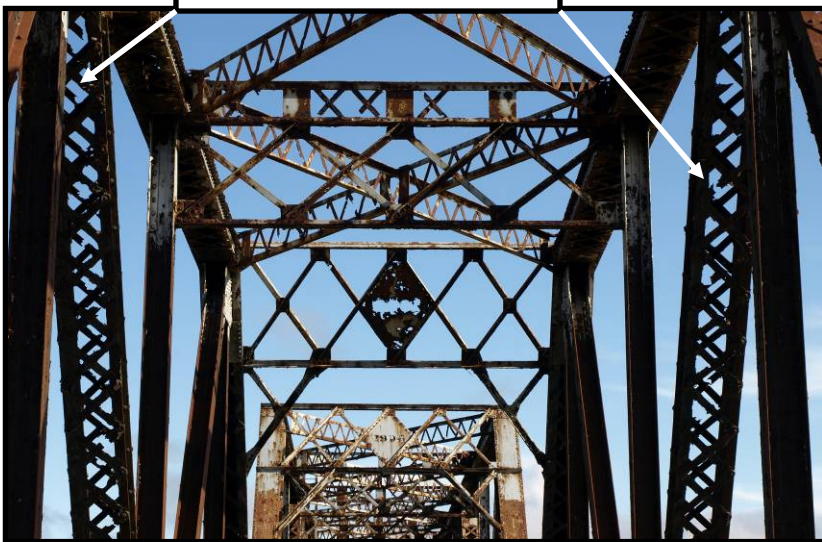
Photograph No. 8 – View shows corrosion and section loss of lacing bars on both truss diagonals of Span 2, Panel 3.

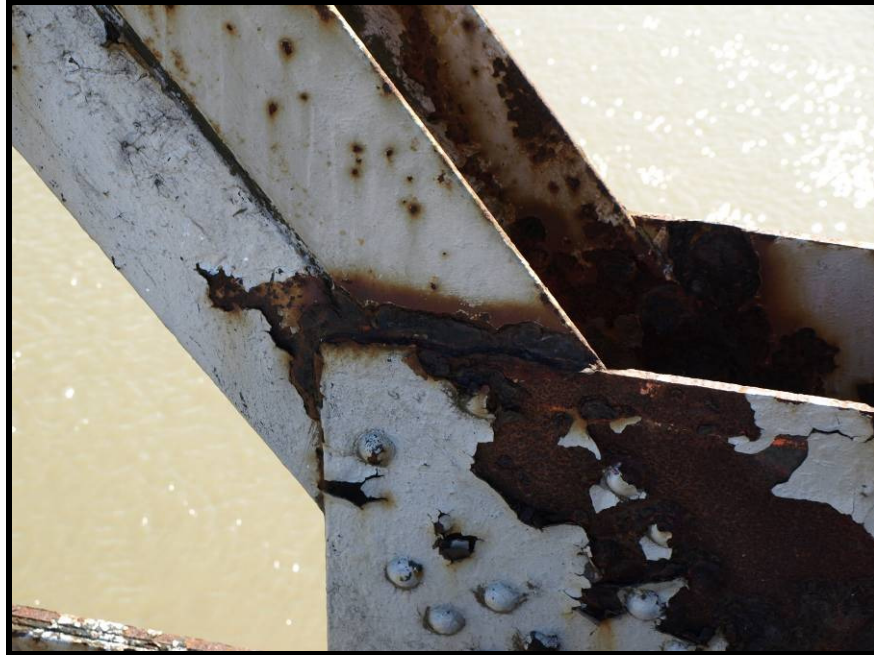
Photograph No. 9 – View shows corrosion and section loss of inboard flanges of diagonal L4-U5 of the left truss of Span 4.

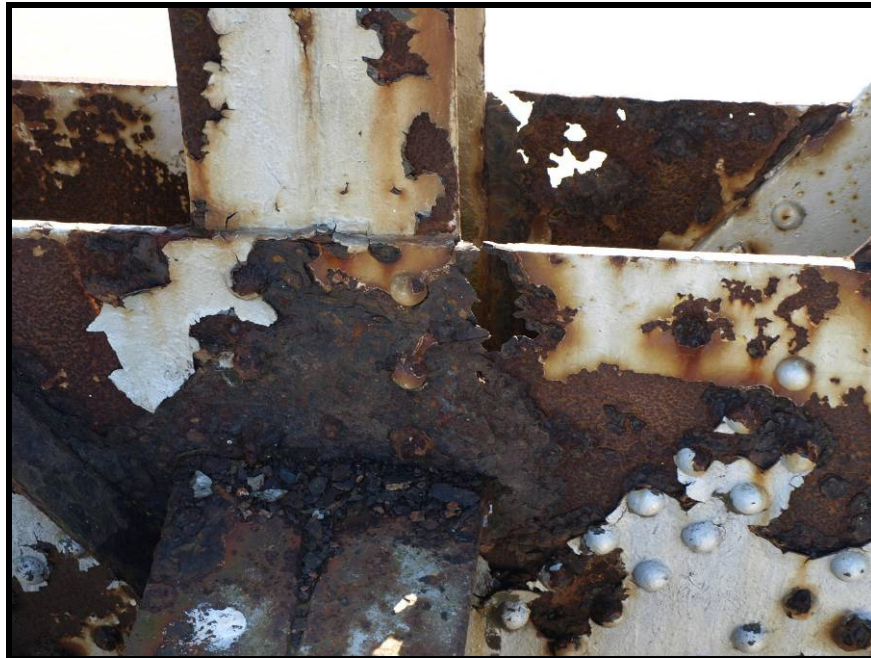
Photograph No. 10 – View shows corrosion and section loss of inboard and outboard gusset plates at Span 4, Panel Point L2L.

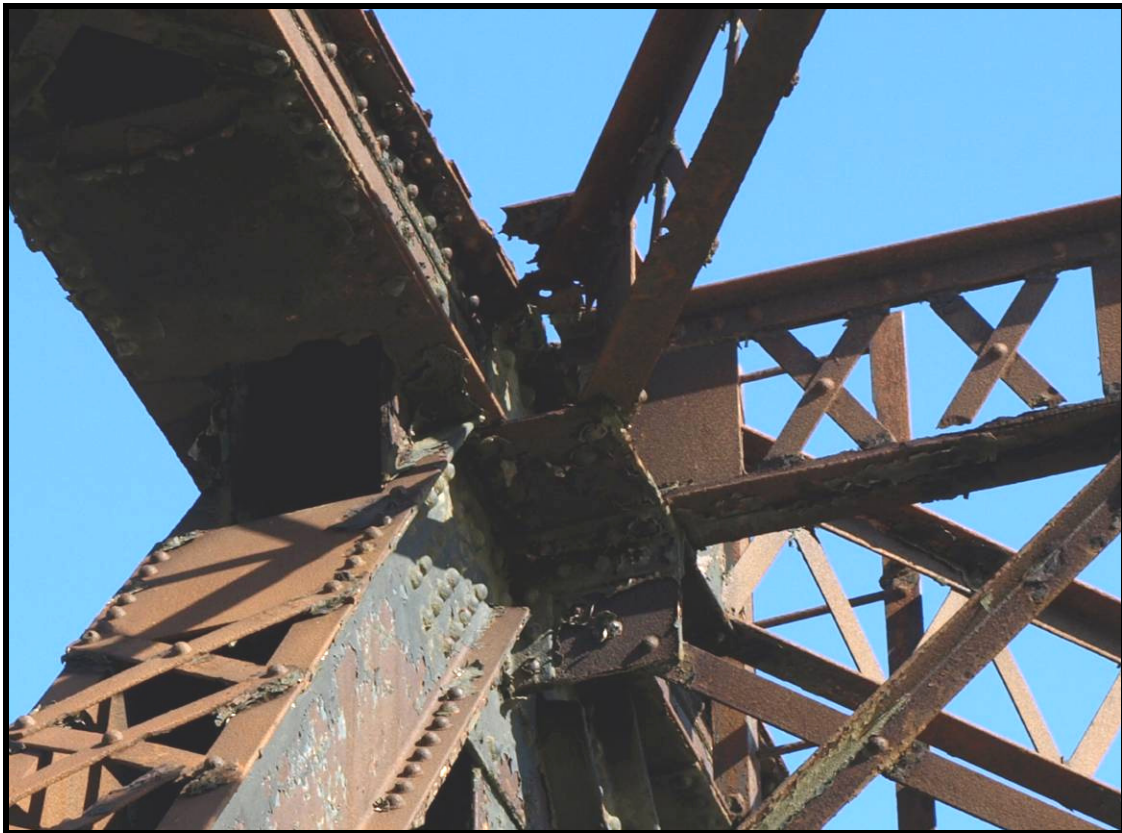
Photograph No. 11 – View shows section loss in top lateral brace connection plate at Panel Point L3L of Span 5.

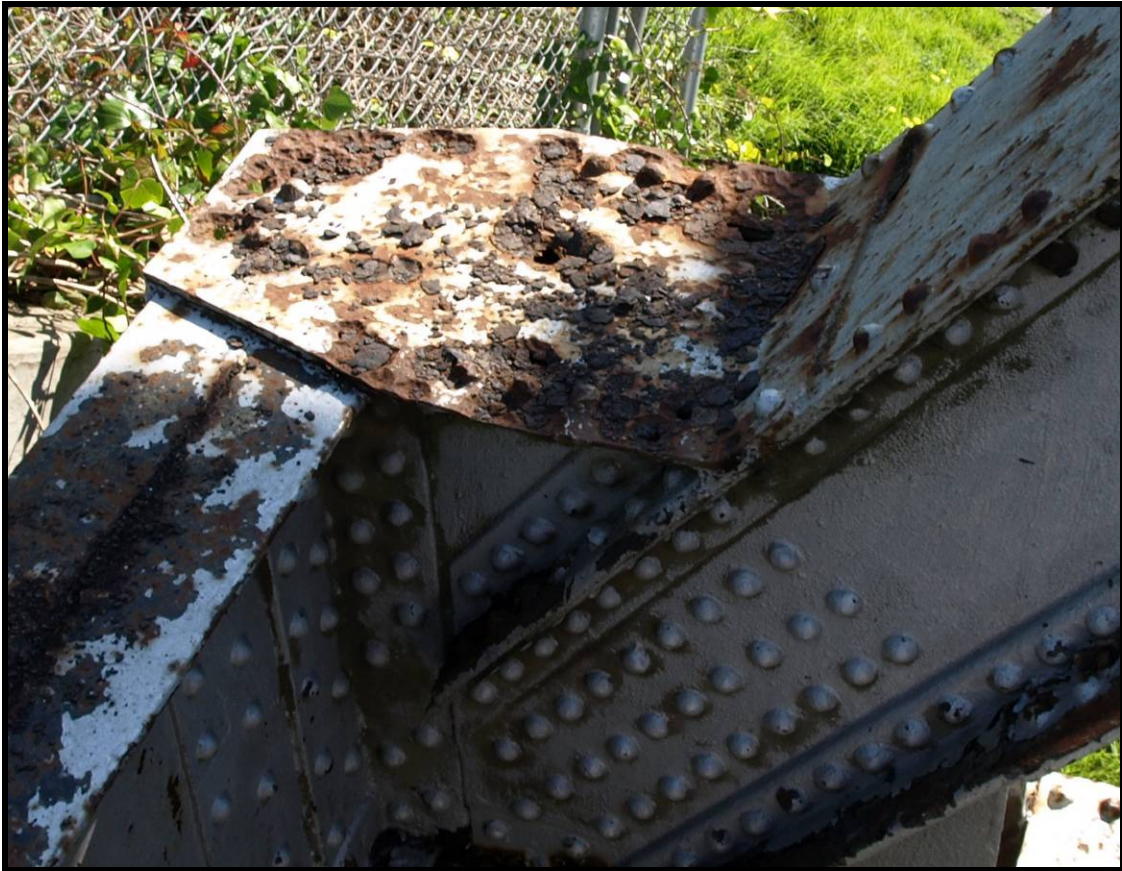
Photograph No. 16 – View of the end post-to-floorbeam connection plate of span 1 at LOL.

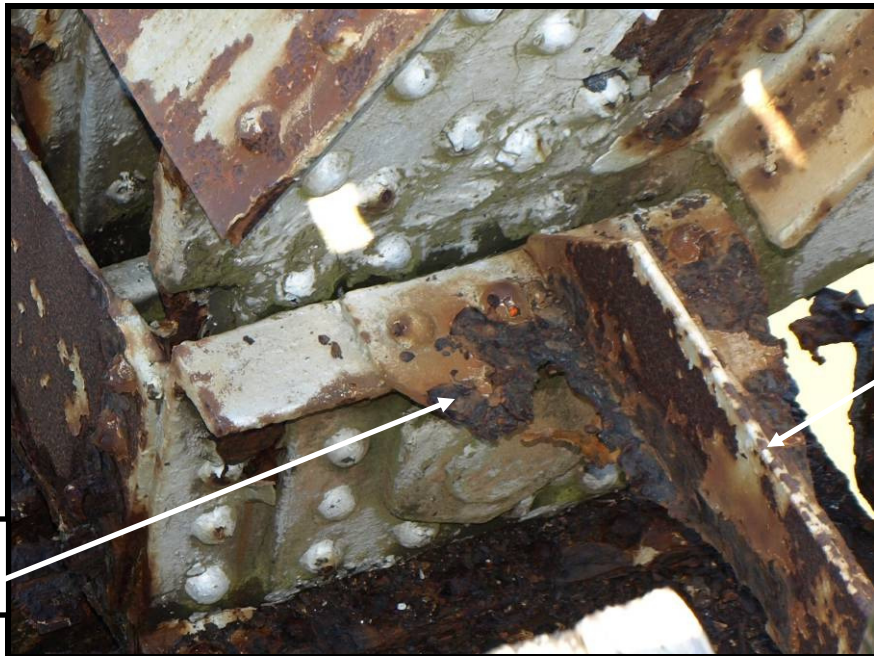
The floor system of the Salinas River Bridge has a fair amount of increased deterioration and section loss occurring after the completion of the 2001 Modjeski and Masters, Inc. inspection report (5% to 10% increase). As discussed in the 2001 Modjeski and Masters, Inc. inspection report, most of the floor system deterioration is found in Span 1. The majority of the increased deterioration in Span 1 occurs in secondary members such as connection plates and floorbeam brackets (see **Photograph No. 16-17**), as well as stringer lateral members and stringer lateral gusset plates. An increase of deterioration and section loss was found in the stringer strut and stringer strut gusset plates of Spans 2-5, (see **Photograph No. 18**).

Photograph No. 18 – View shows corrosion and section loss in stringer strut & strut gusset plate at Panel Point L6R of Span 4
