TRANSPORTATION AGENCY FOR MONTEREY COUNTY

BRIDGE STRATEGY REPORT FOR THE MONTEREY PENINSULA LIGHT RAIL PROJECT

PARSONS
July 2005
May 2010 Update

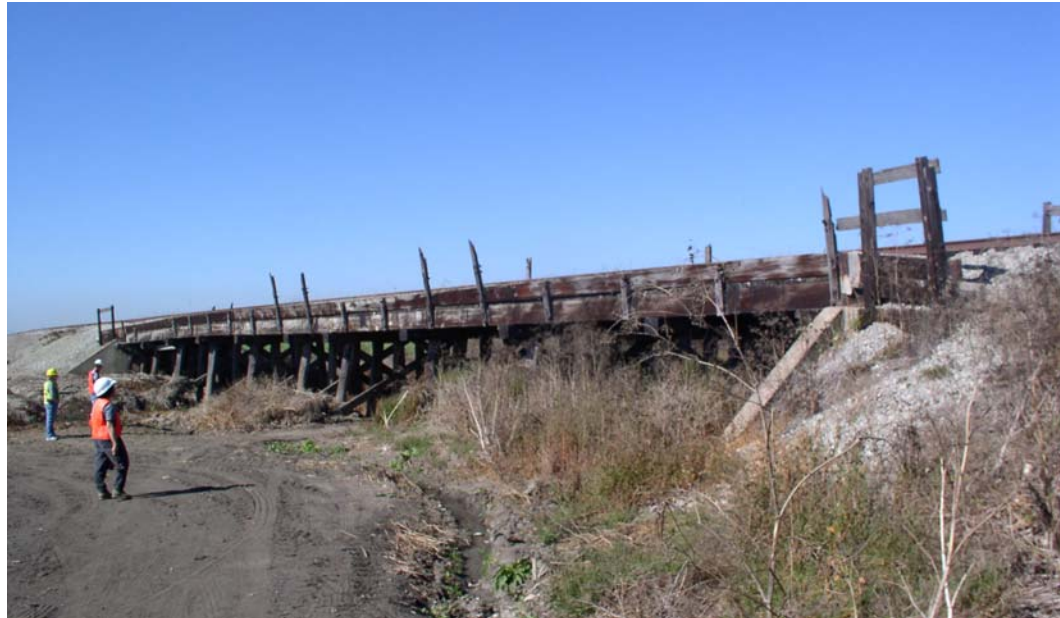
M.P. 111.05—Tembladero Slough, 150-foot Ballast Deck Trestle on Timber Piles

For service option 3, non-compliant DMU/EMUs (**EMU equipment dropped from further consideration**), TAMC may want to retain the existing bridge. With these lightweight cars, the existing bridge in its current condition most likely has a remaining life of 20 to 30 years.

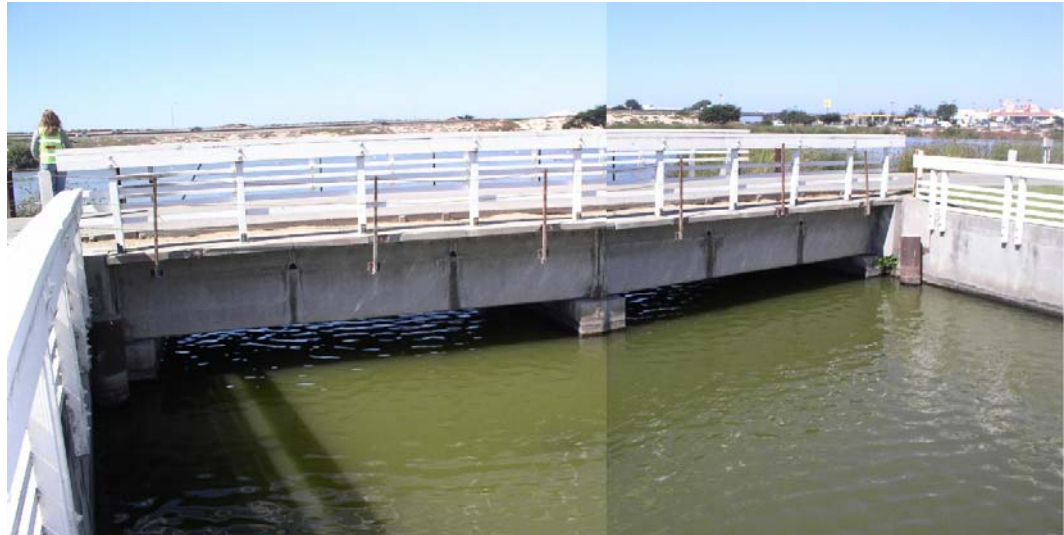
MP 123.80—Lake George, 45-Foot Prestressed Concrete Trestle

This bridge appears to have been constructed in the 1970s or 1980s by Southern Pacific Railroad in accordance with their standard plans. It is a 2-span bridge with each span being 22-feet 6-inches, most likely designed for a minimum E72 live load. It requires no repairs prior to re-establishing train service. It is anticipated that no or very limited seismic retrofitting would be required. The existing bike path would be removed and the track reconstructed.

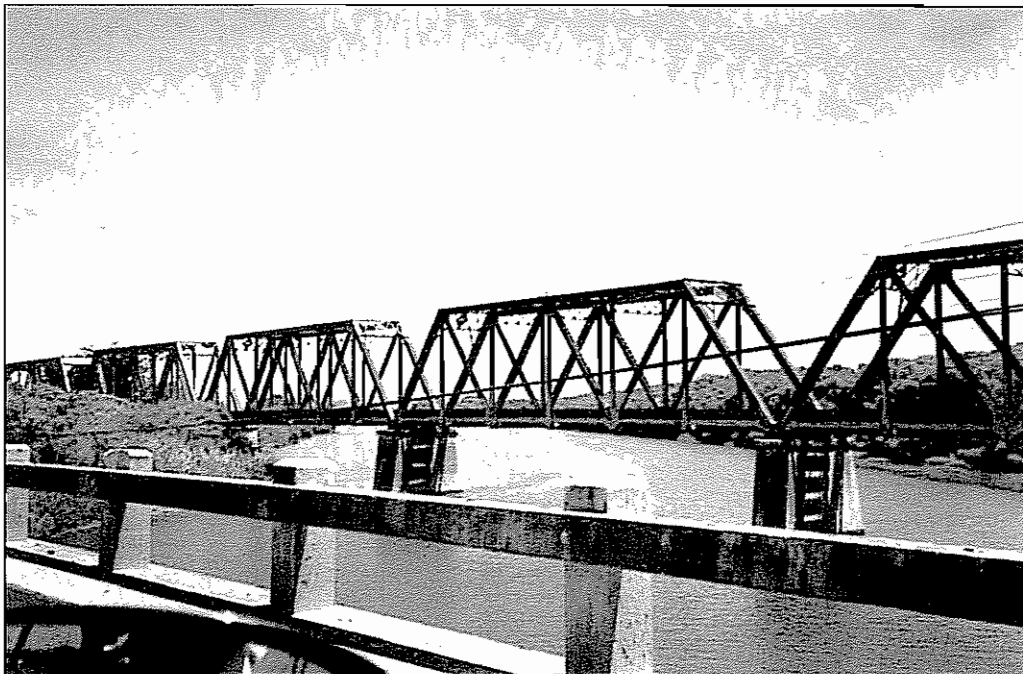
Photograph No. 1 – View of Spans 1-4 (left to right) and the first two panels of Span 5, from a highway bridge located between the railroad bridge and Highway 1 bridge.

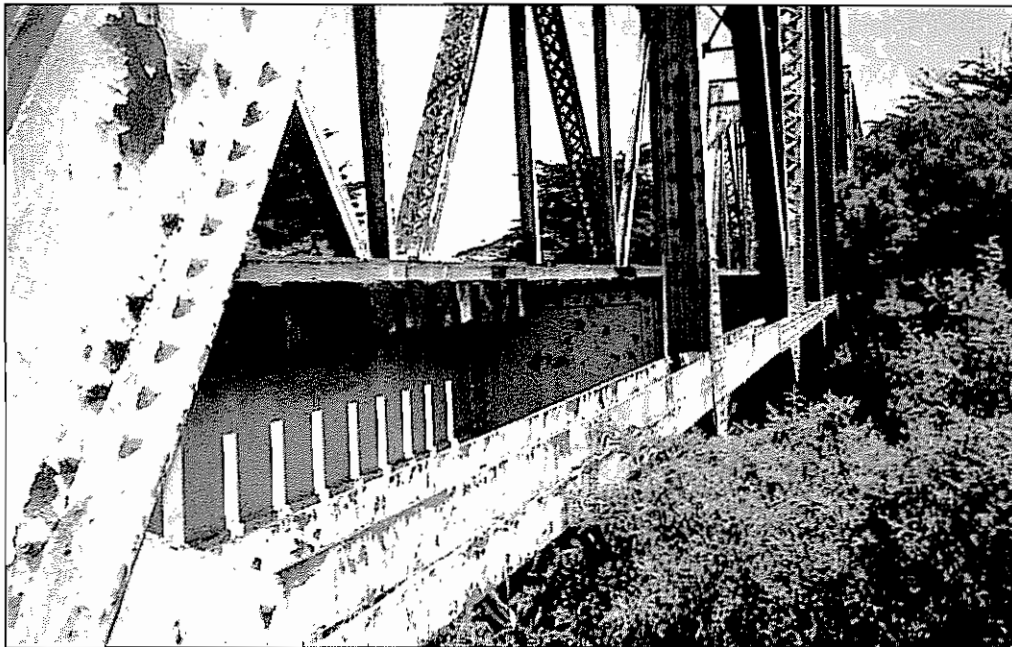
Photograph No. 5 – View shows the bottom chord of the left truss of Span 2. Note that most of the paint still remains on visible portions of the bottom chord and adjacent floor system components.

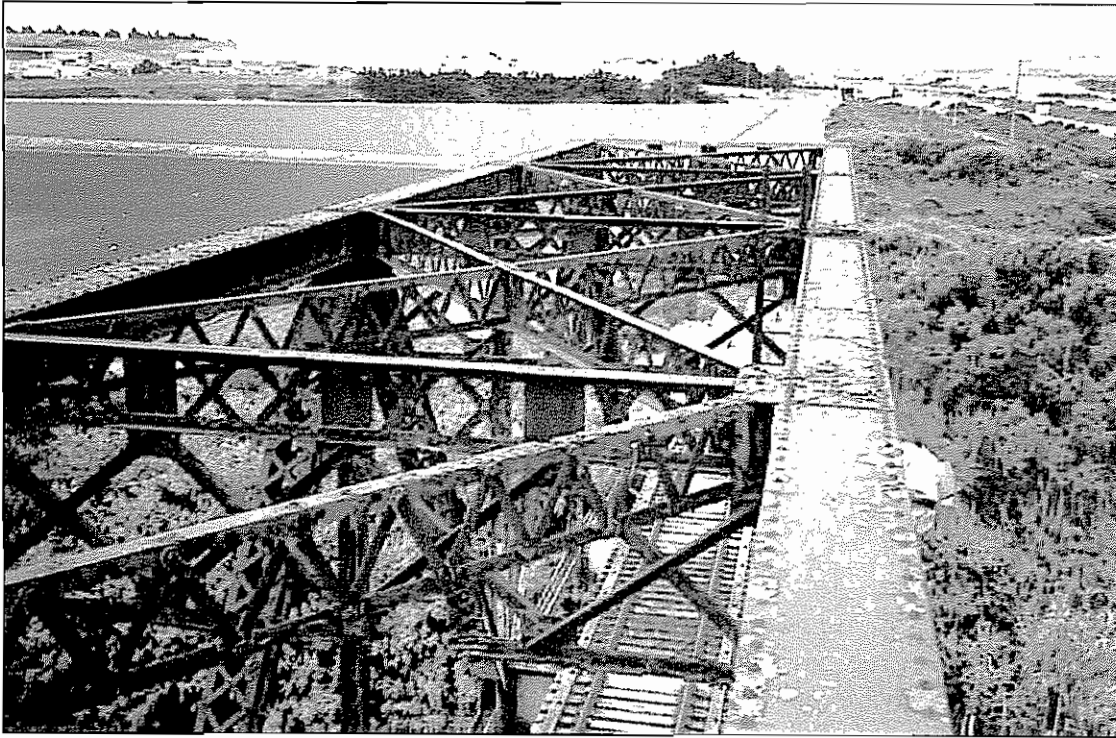
Photograph No. 6 – View shows the top chord and upper truss bracing of Span 5. Note that there is very little paint remaining on the visible surfaces.

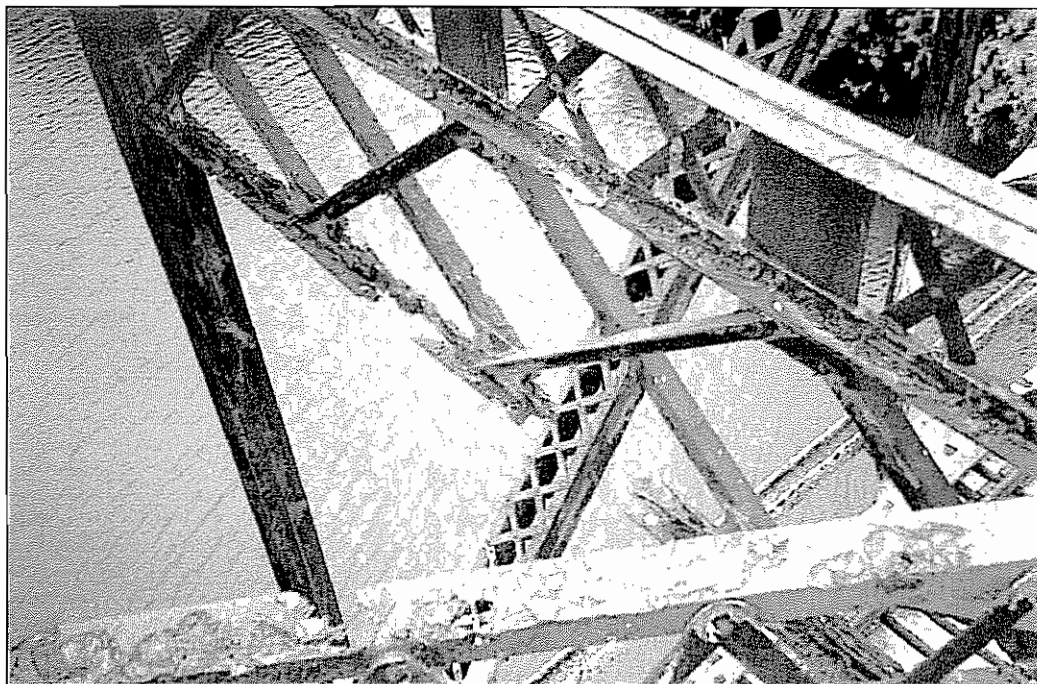
The most extensive and severe section loss within the truss bracing has occurred at upper connection plates of top lateral members, some of which no longer provide a connection between the lateral and top chord, as shown in **Photograph No. 10**. In addition, severe section loss has also occurred at some top and bottom lateral members, and at portions of top struts and sway frames, as shown in **Photograph No. 11**.

Photograph No. 11 – View shows 100% section loss of the bottom angles of the sway bracing between Panel Points U2L & U2R of Span 5.

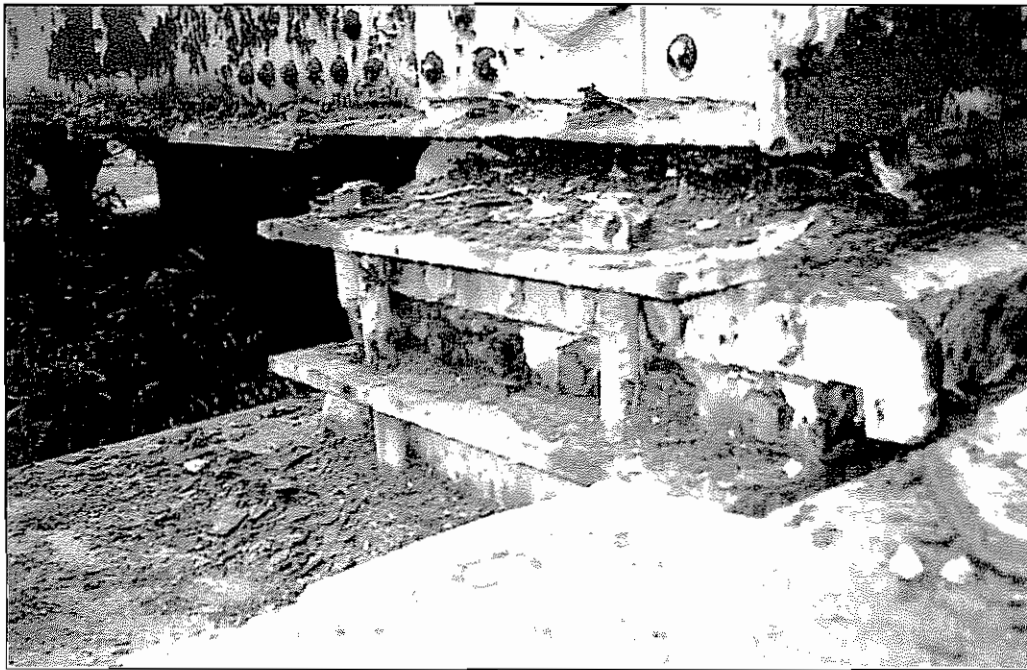
At most locations, segmental rollers of the truss expansion bearings appear to be frozen, and at Span 1 the segmental rollers are no longer centered under the upper bearing plate and appear to be “working out” (see **Photograph No. 12**).

Photograph No. 12 – View of the truss expansion bearing of Span 1, right side. Note that the segmental roller at the right side of the photo is no longer under the upper bearing plate.

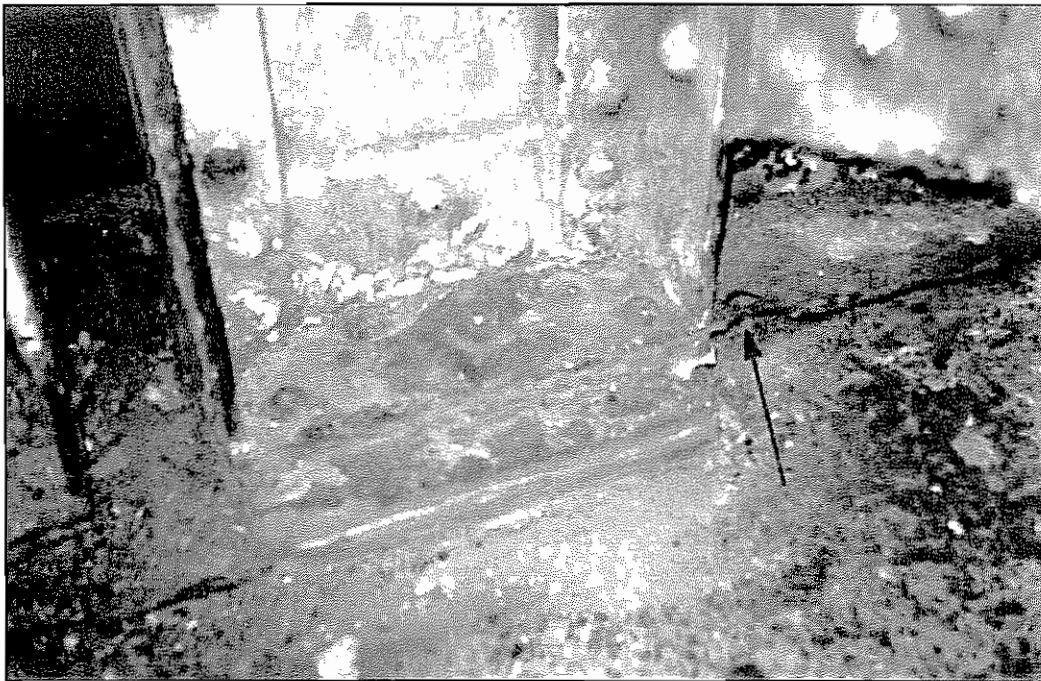
Photograph No. 17 – View of the bottom flange of the right stringer in Panel 1 of Span 5, at the fixed bearing at Pier 4. Note location where 30% section loss has occurred (arrow).

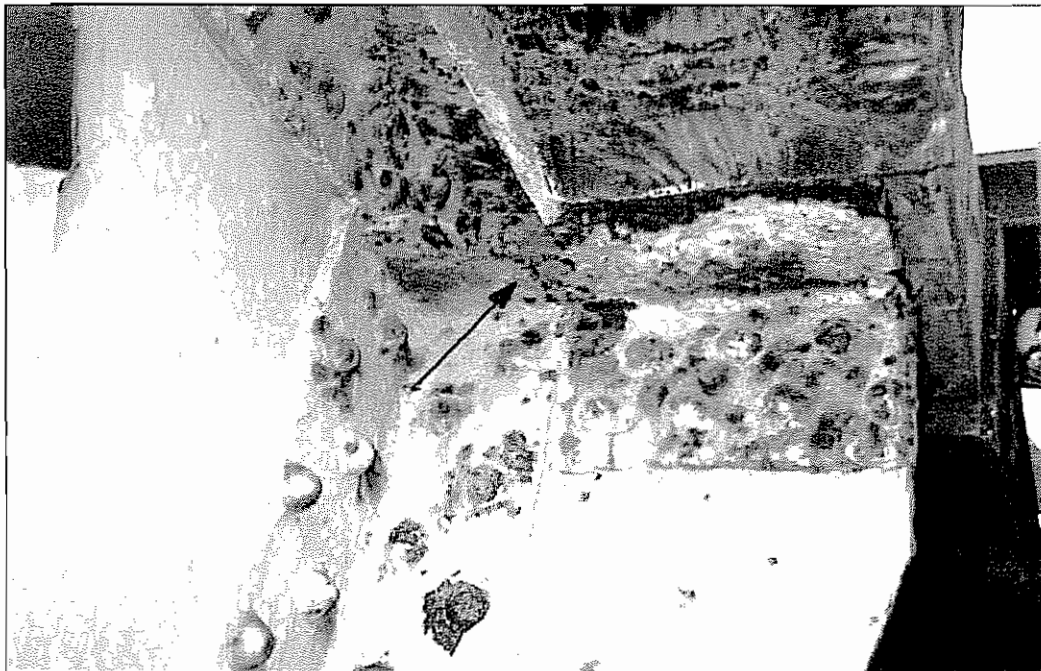
Photograph No. 18 – View shows 100% section loss of the inboard top flange of the right stringer bracket, at Floorbeam 6 of Span 1

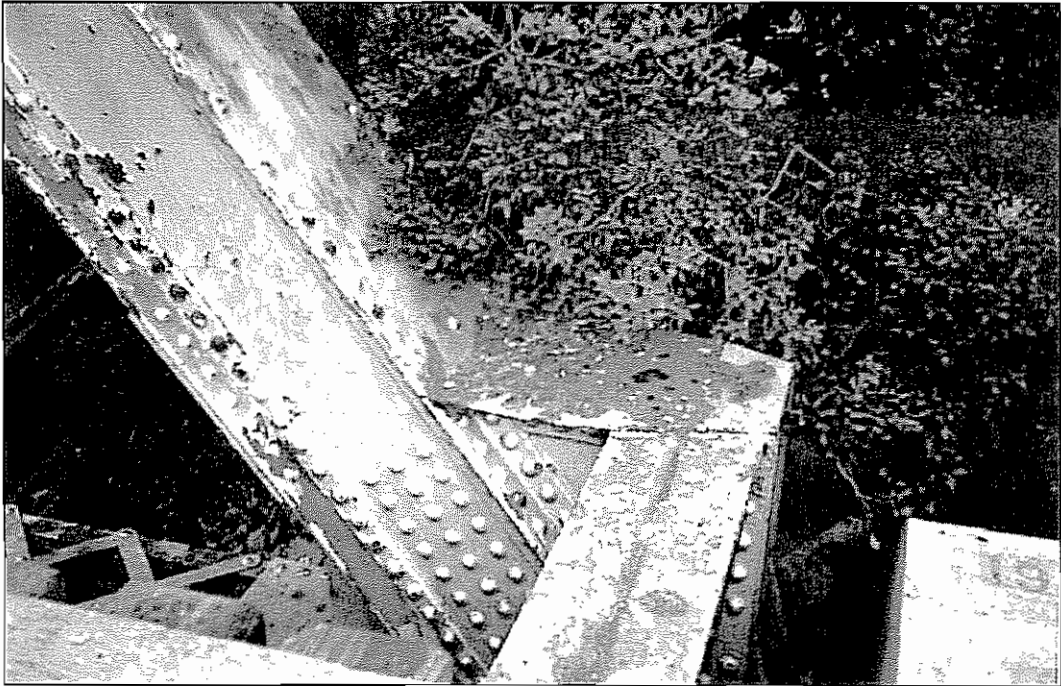
Photograph No. 19 – View of the end post-to-floorbeam connection plate of Span 1 at L0, right side. Note the holes in the plate, which has 70% section loss overall.

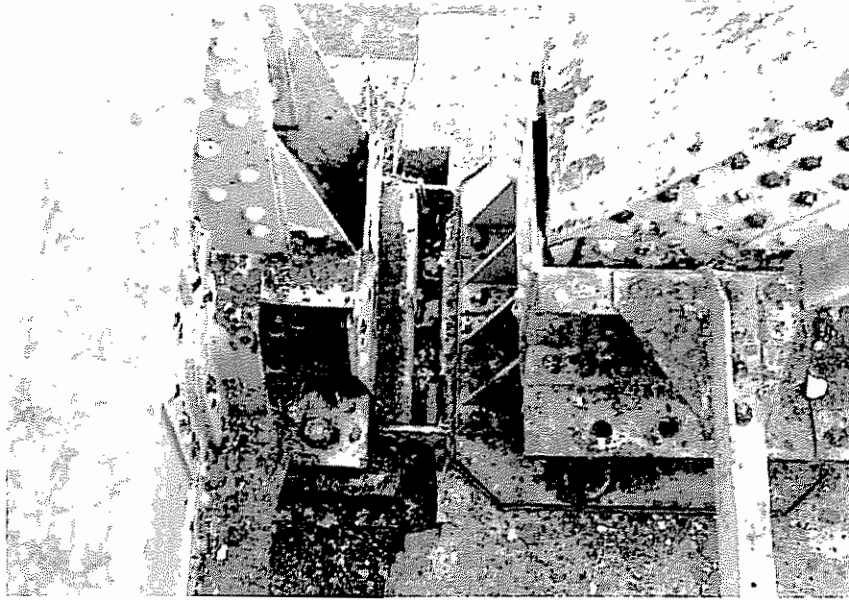
PHOTOGRAPH NO. 18 - View of the left expansion roller nest exposed at Pier 2 (east end of Span 1). Pier 2 shifted to the east (right).

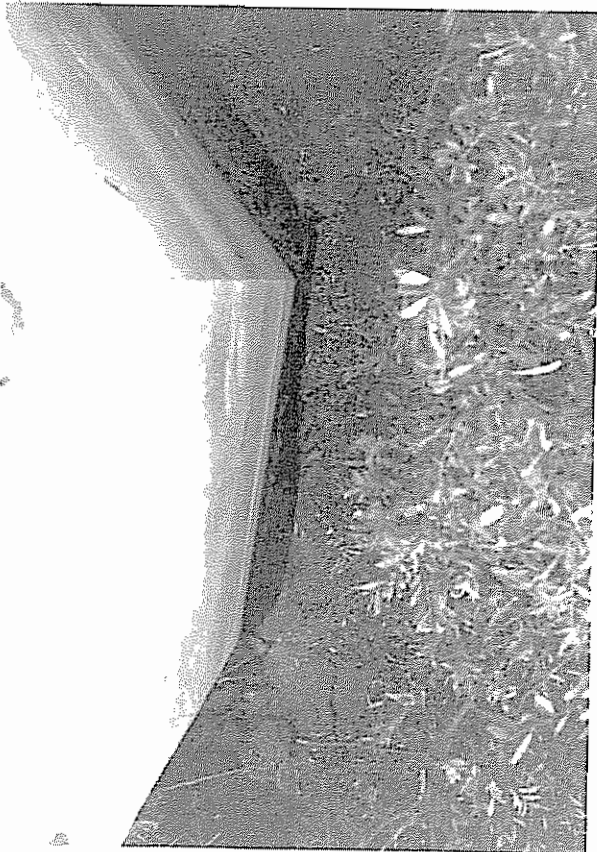
PHOTOGRAPH NO. 19 - View of gap between pier and ground indicating pier movement during the quake.

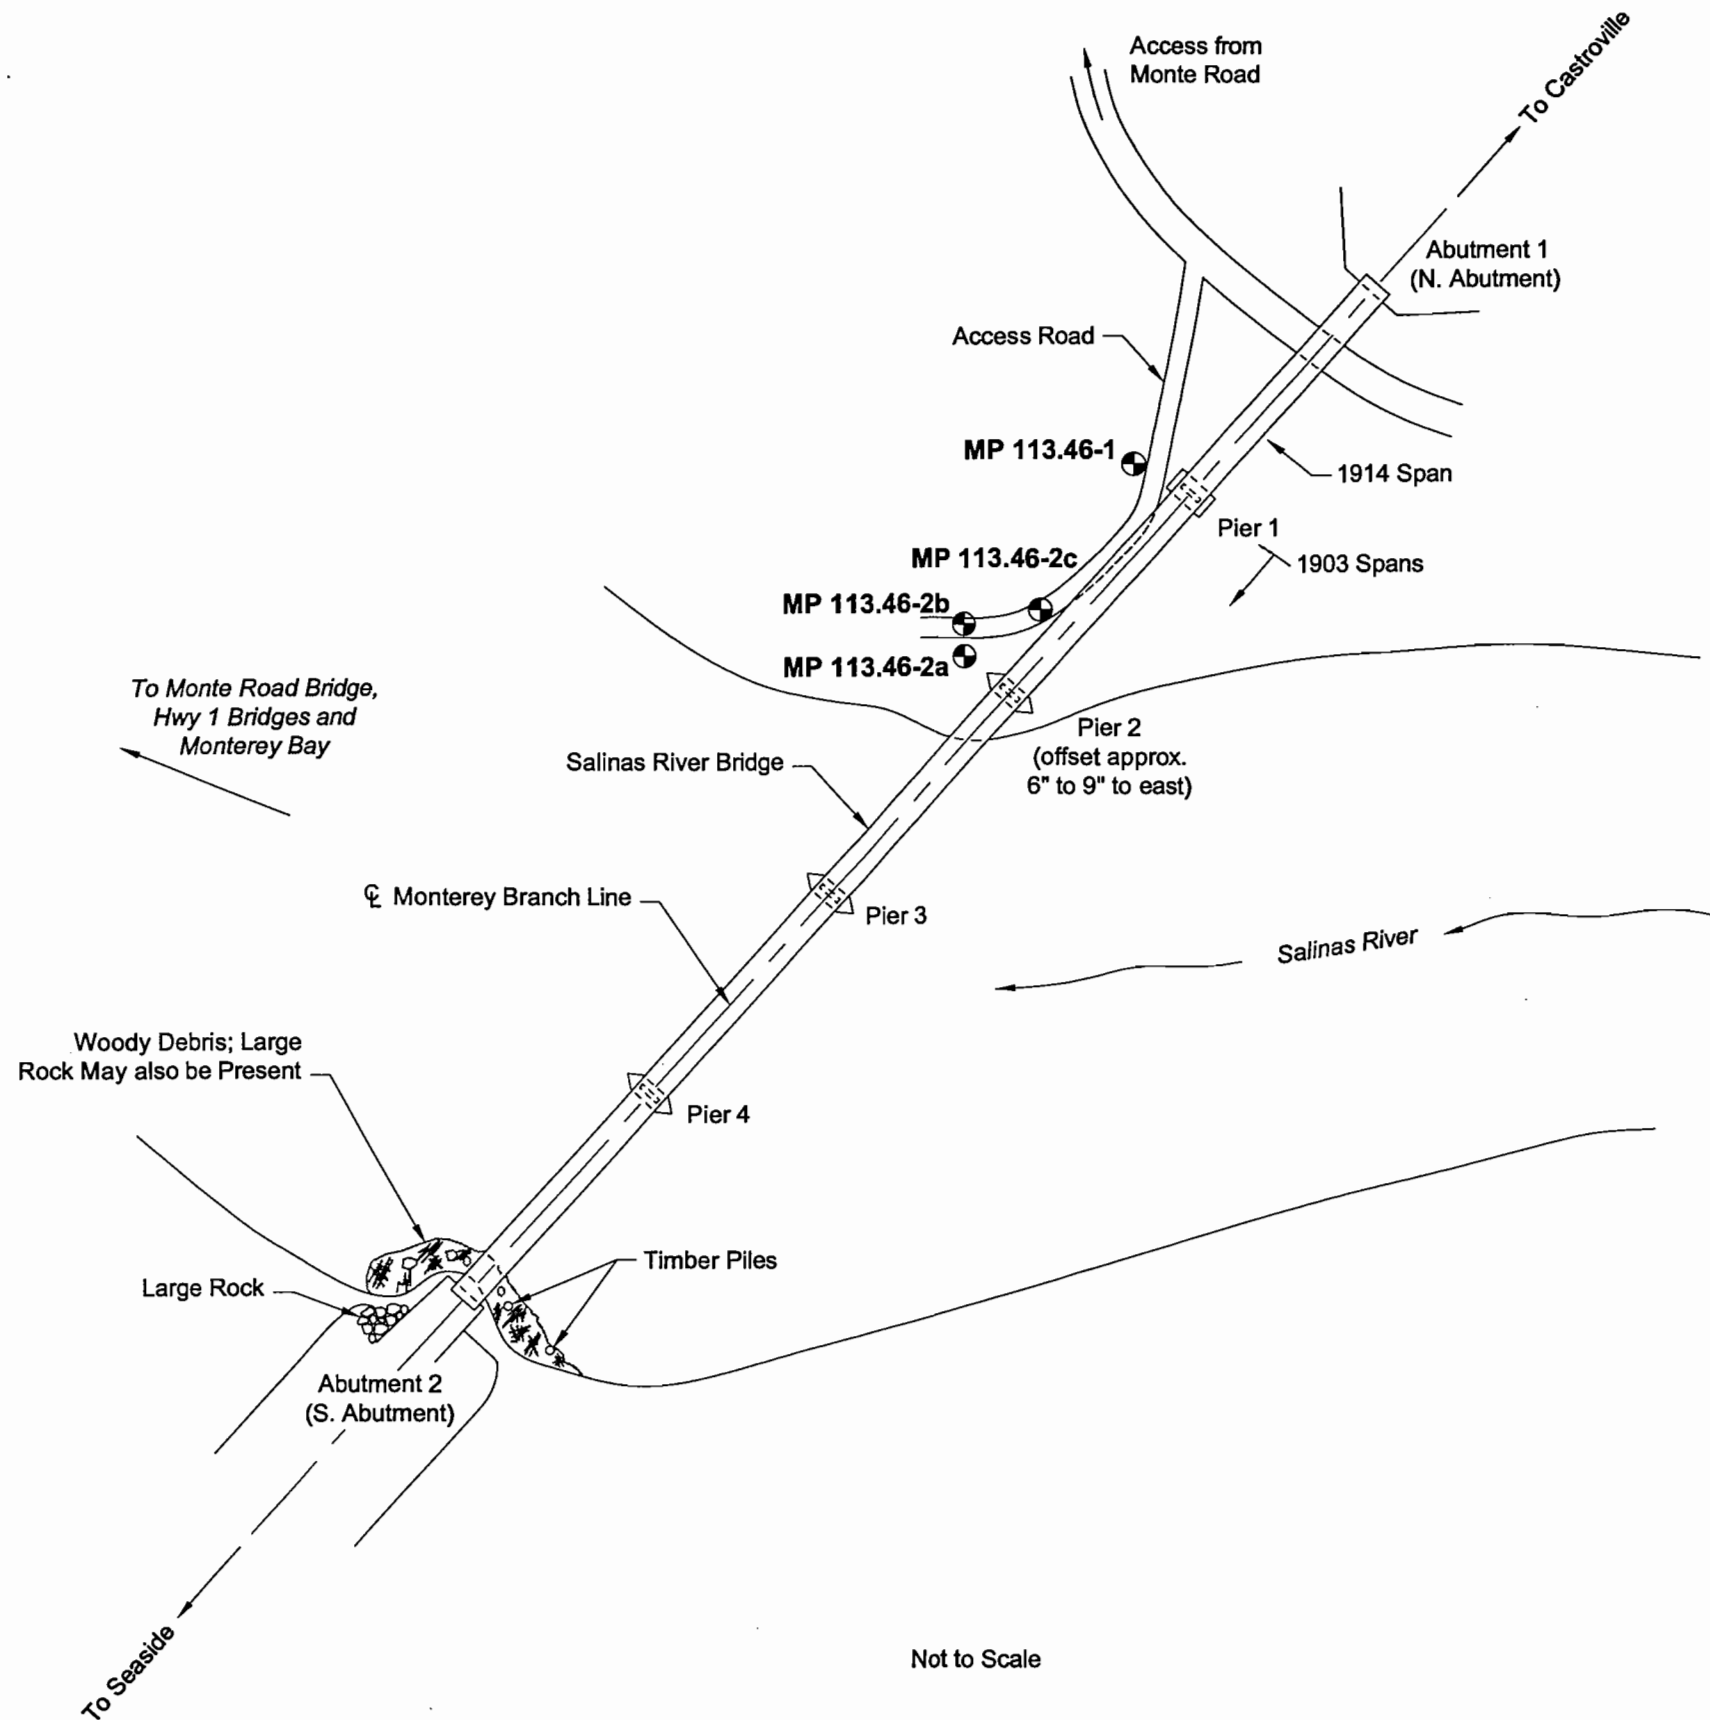
Subsurface conditions near the Salinas River Bridge were explored by drilling four soil borings, ranging in depth from 26 to 121.5 feet. The borings were drilled near the west side of Piers 1 and 2, at the approximate locations shown on Figure 4. Three borings were accomplished near Pier 2. The second and third borings near this pier, borings MP 113.46-2b and MP 113.46-2c, were drilled because rock that stopped advance of the drill was encountered in borings MP 113.46-2a and MP 113.46-2b at relatively shallow depth. Possible explanations for the presence of this rock in an area where only alluvial deposits were anticipated are presented elsewhere in this report.

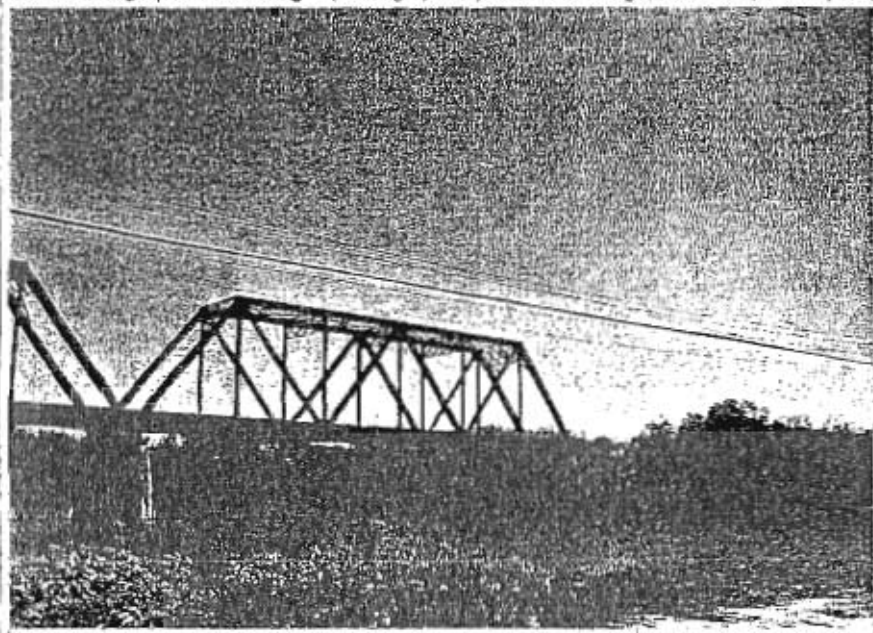
Looking towards the southern abutment at Spans 4 and 5 May 2002

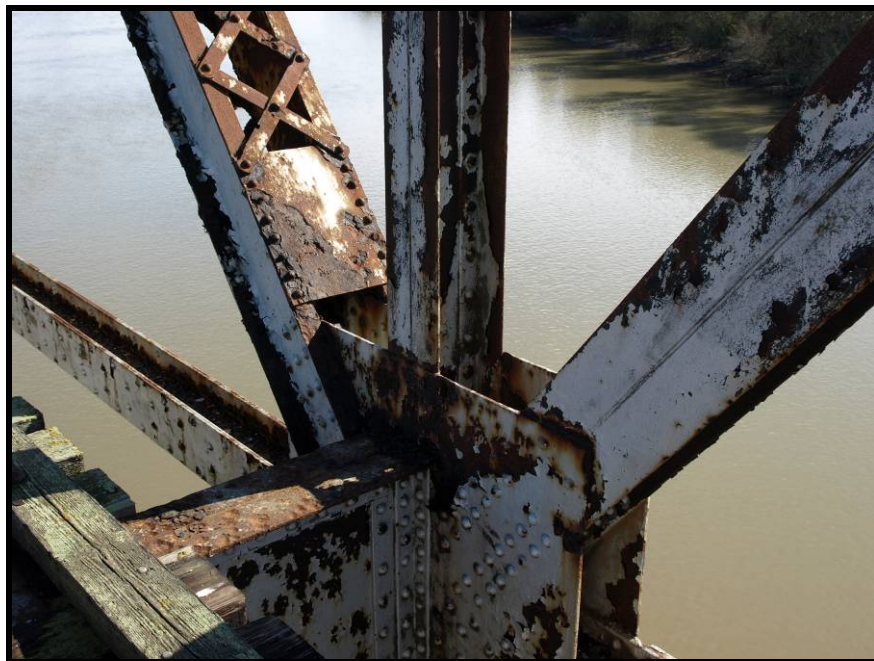
Photograph No. 2 – View of paint loss at Panel Point L4L of Span 5.

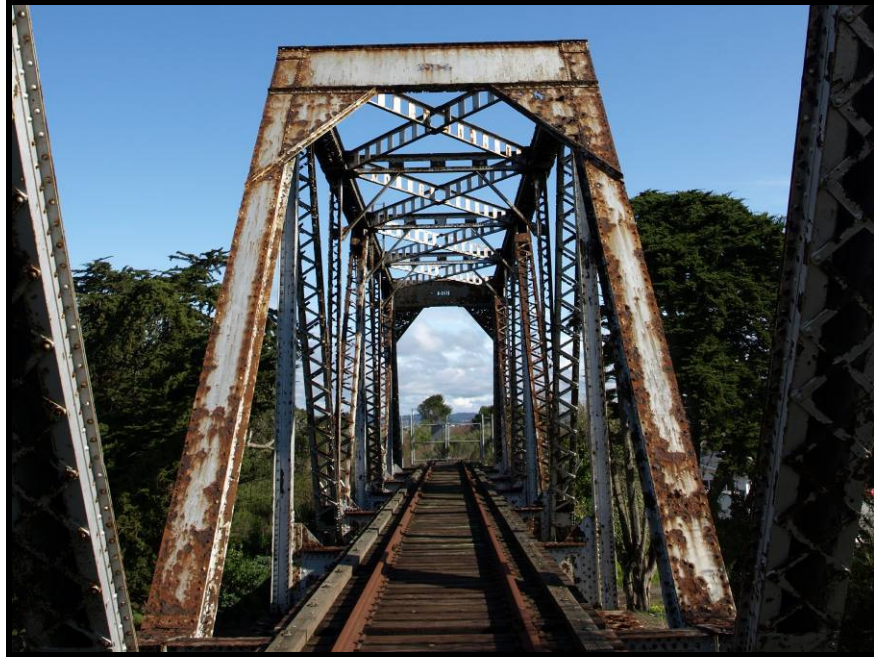
Photograph No. 3 –View of paint loss on various truss members of Span 1 looking North.

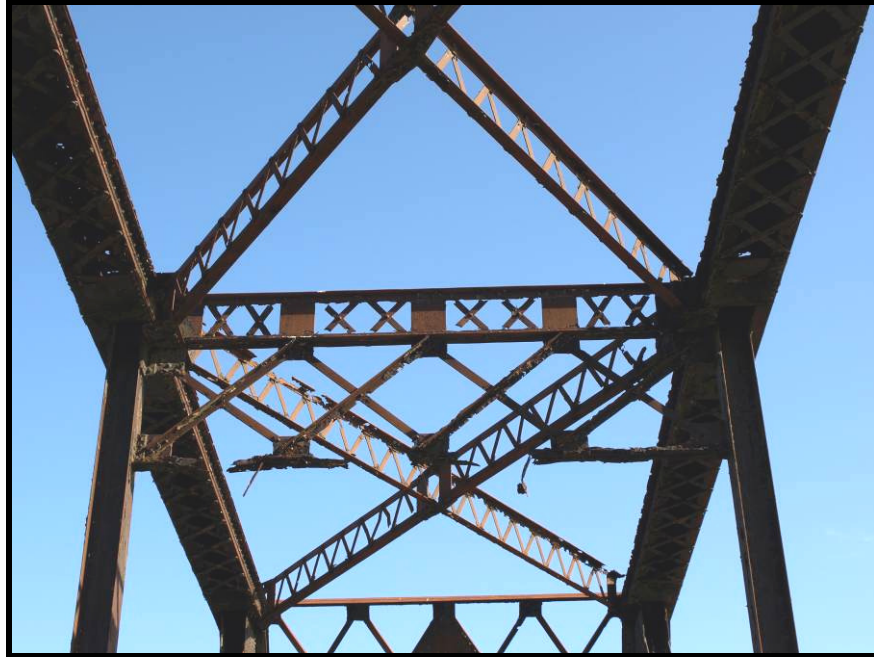
Photograph No. 12 – View shows section loss in top sway and strut brace at Panel Point L2L of Span 5.

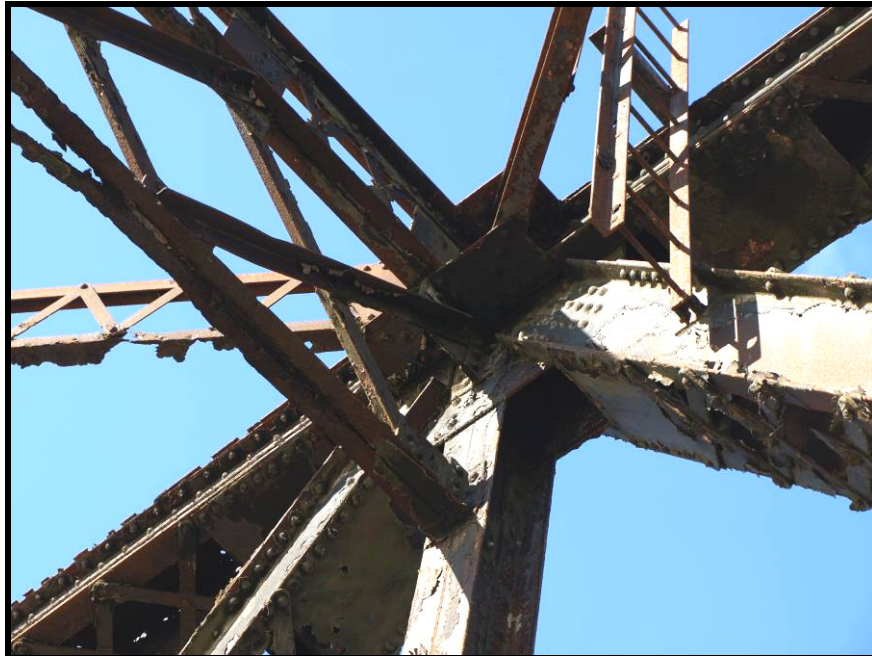
Photograph No. 13 – View shows section loss in top lateral brace & top sway brace at Panel Point L3L of Span 4.

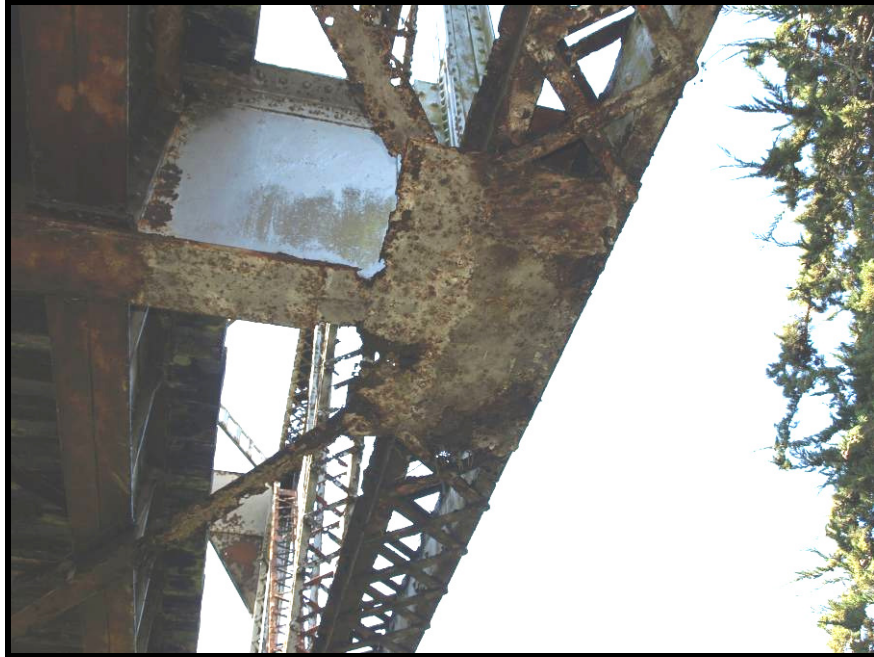
Photograph No. 14 – View shows section loss in bottom lateral brace & gusset plate at Panel Point L3L of Span 1.

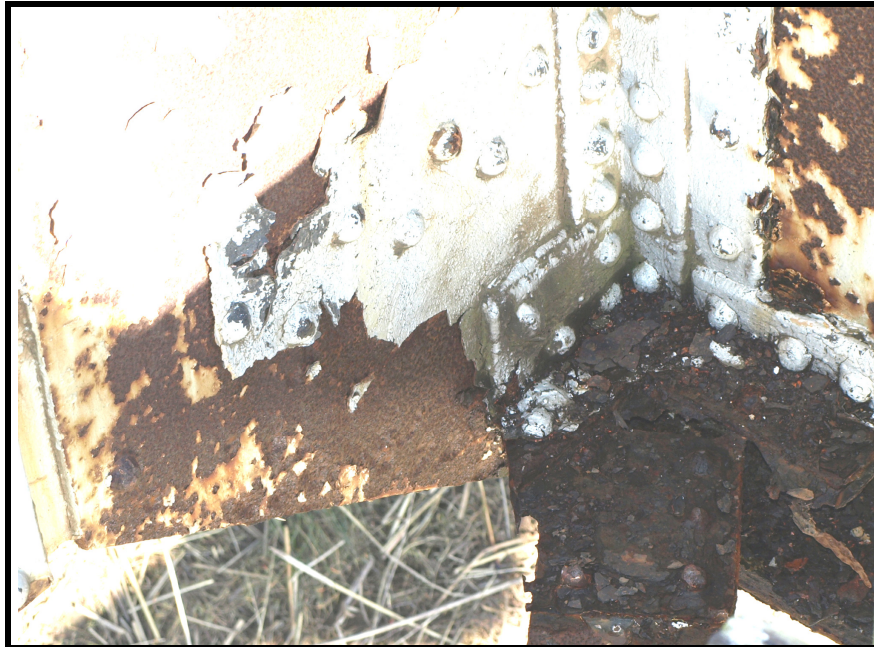
Photograph No. 15 – View shows section loss in bottom lateral brace gusset plate at Panel Point L4R of Span 3.

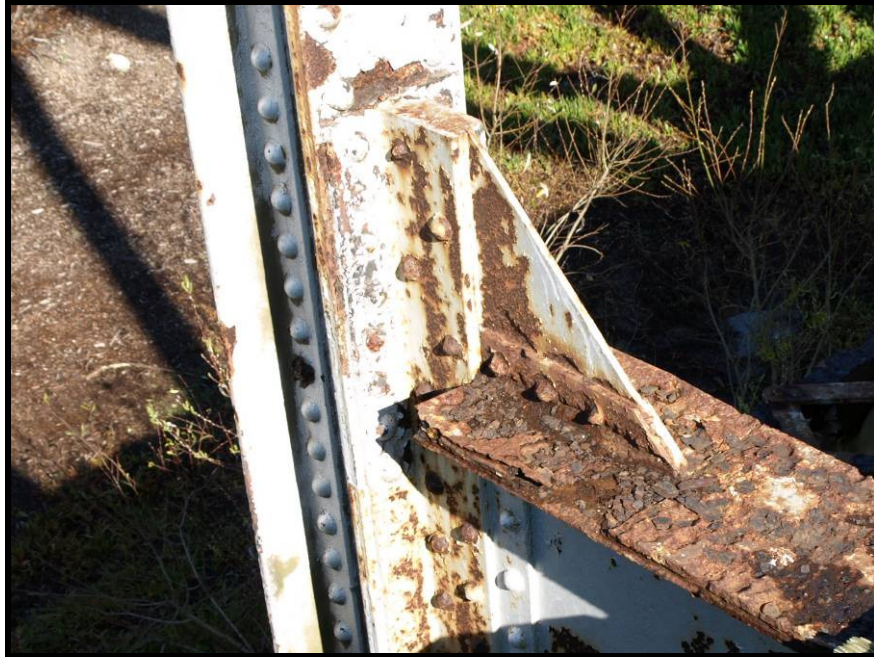
Photograph No. 17 – View shows the right floorbeam bracket of Floorbeam 5 of Span 1
